City of Morro Bay
Water Reclamation Facility Project

OUTFALL ASSESSMENT PLAN

DRAFT | March 2020

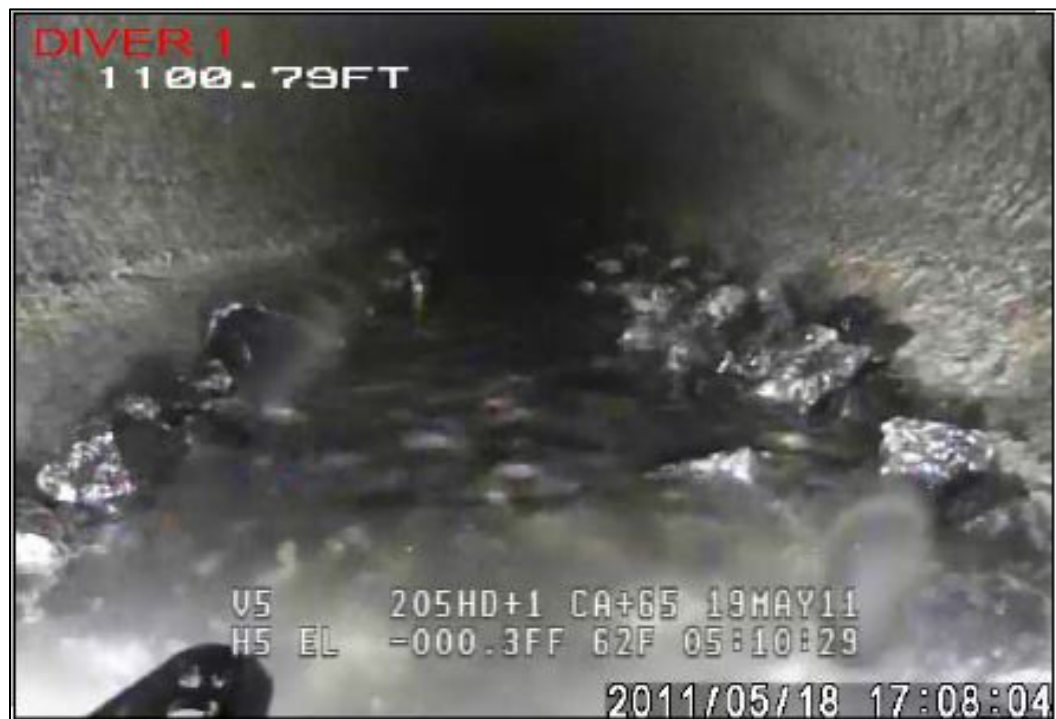
Figure 4 Typical ROV Inspection Photo

The ocean outfall pipeline and diffuser section were visually inspected by a remotely operated vehicle (ROV) in 2011 by Ballard Diving & Salvage. This inspection can be found in Appendix A. In order to complete the internal inspection, the outfall pipeline was required to have a controlled flow to assist the ROV progression through the pipeline. Having flow in the pipeline prevented a clear image, therefore the inspection heavily relied on sonar to record sedimentation and other defects throughout the outfall. There were times when flow was not in the pipeline during the inspection, Figure 3.5 shows a typical ROV inspection photo from within the pipe without flow. Figure 3.6 shows a typical sonar inspection plot that shows sediment at the pipe invert. The inspection findings are listed below:

- Small debris piles on the invert of the outfall ranged from 1 to 2-inches deep. Debris material consisted of loose sediment, gravel, rubber joint seal sections or pieces of pipe corrosion.
- No significant cracks or out of round conditions were measured.
- Sections of joint seals were hanging from pipe joints.
- 7 of the diffusers were not flowing.

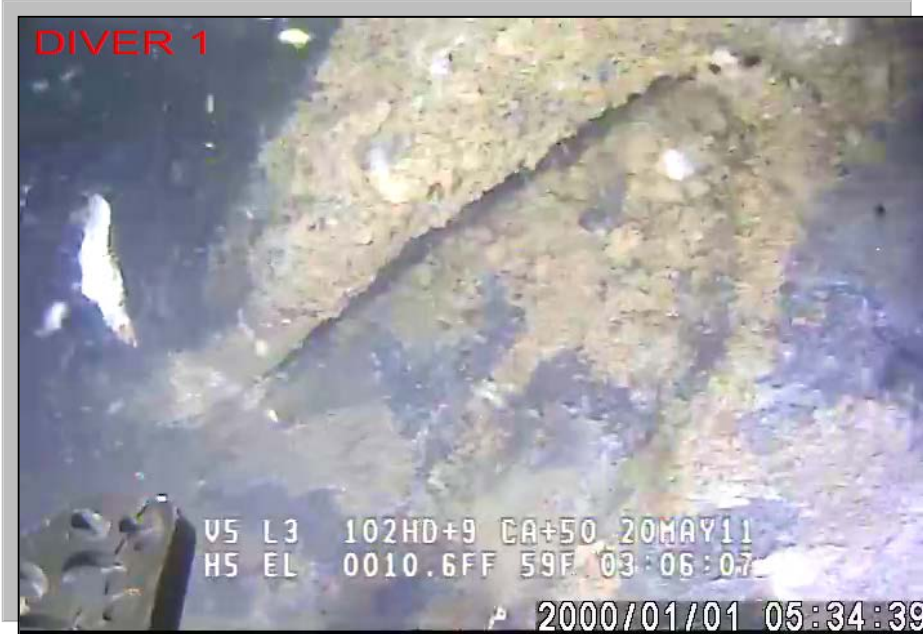
Figure 16 - Seal Loose from Crown between 1300' and 1200'

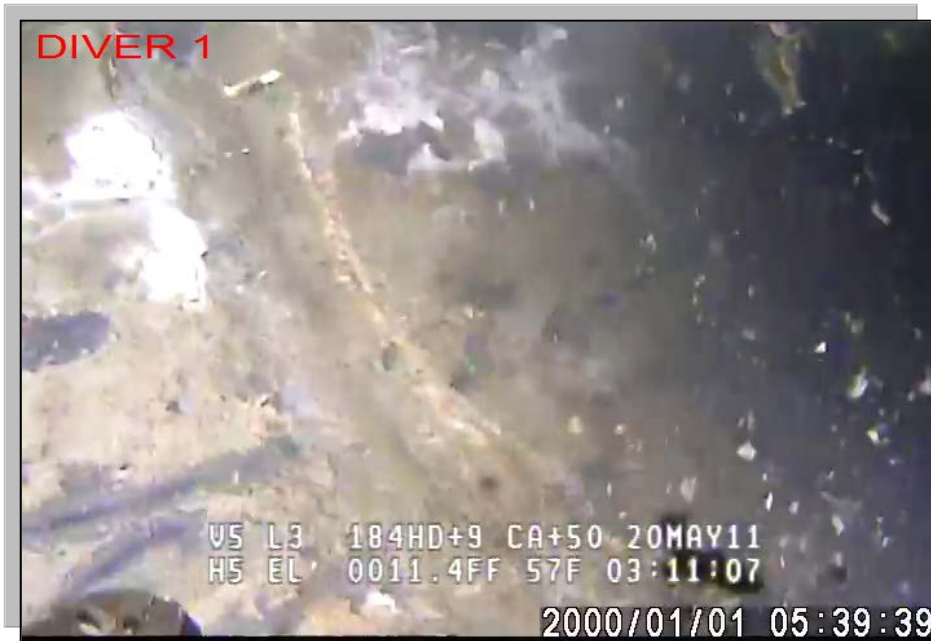
Figure 18 - Seal Missing from Joint between 1100' and 1068'

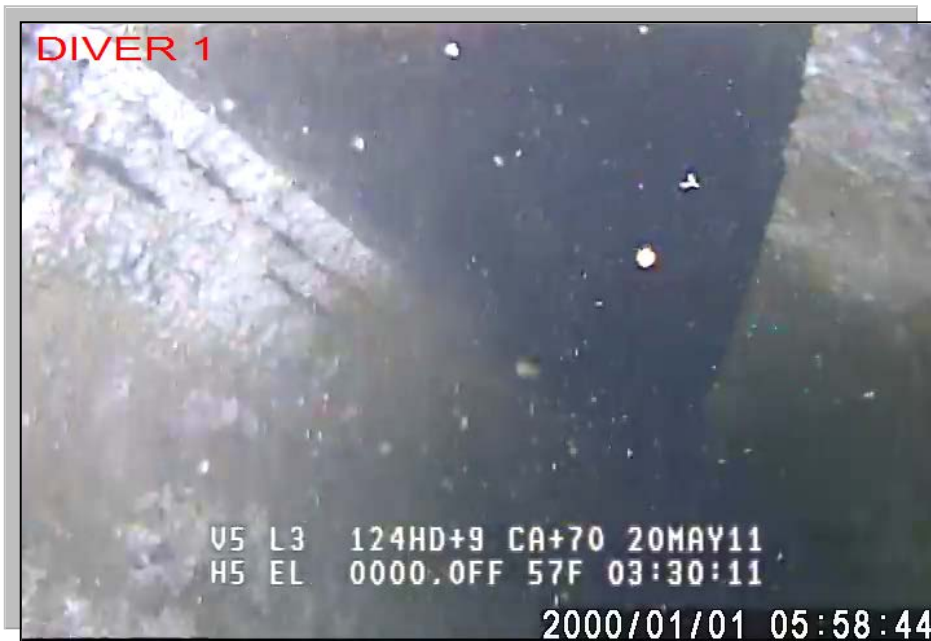
Figure 19 - Start of Air Gap at 815'

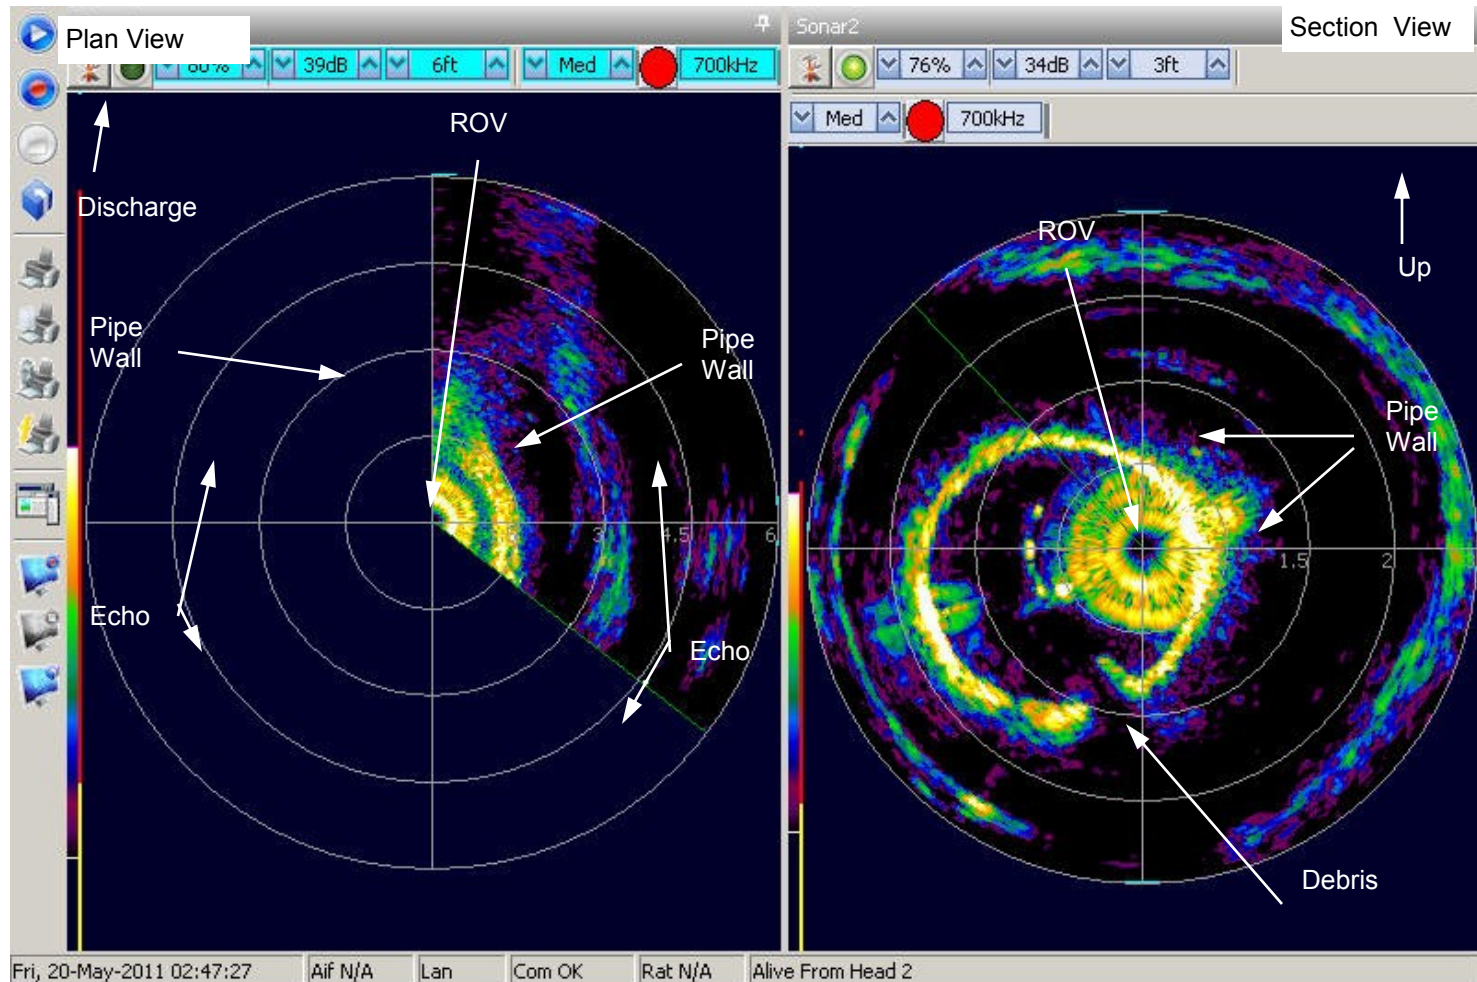
File Name: Morro025.jpg
Tether payout: 1600 feet

Notes: Large piece of debris in the invert.

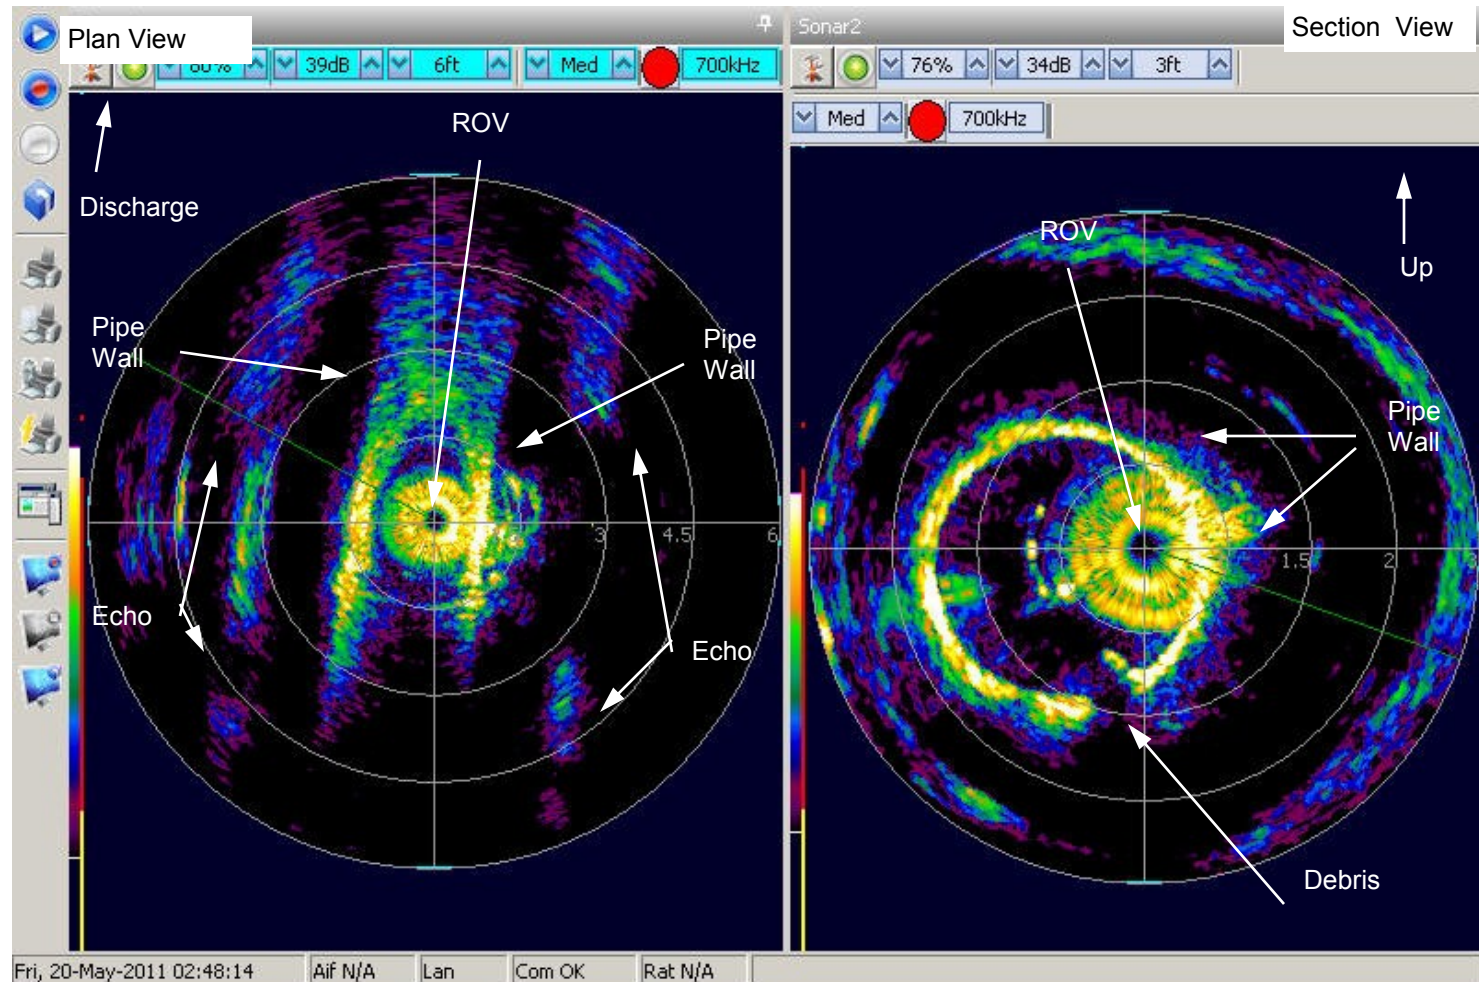
File Name: Morro026.jpg
Tether payout: 1600 feet

Notes: Large piece of debris in the invert.

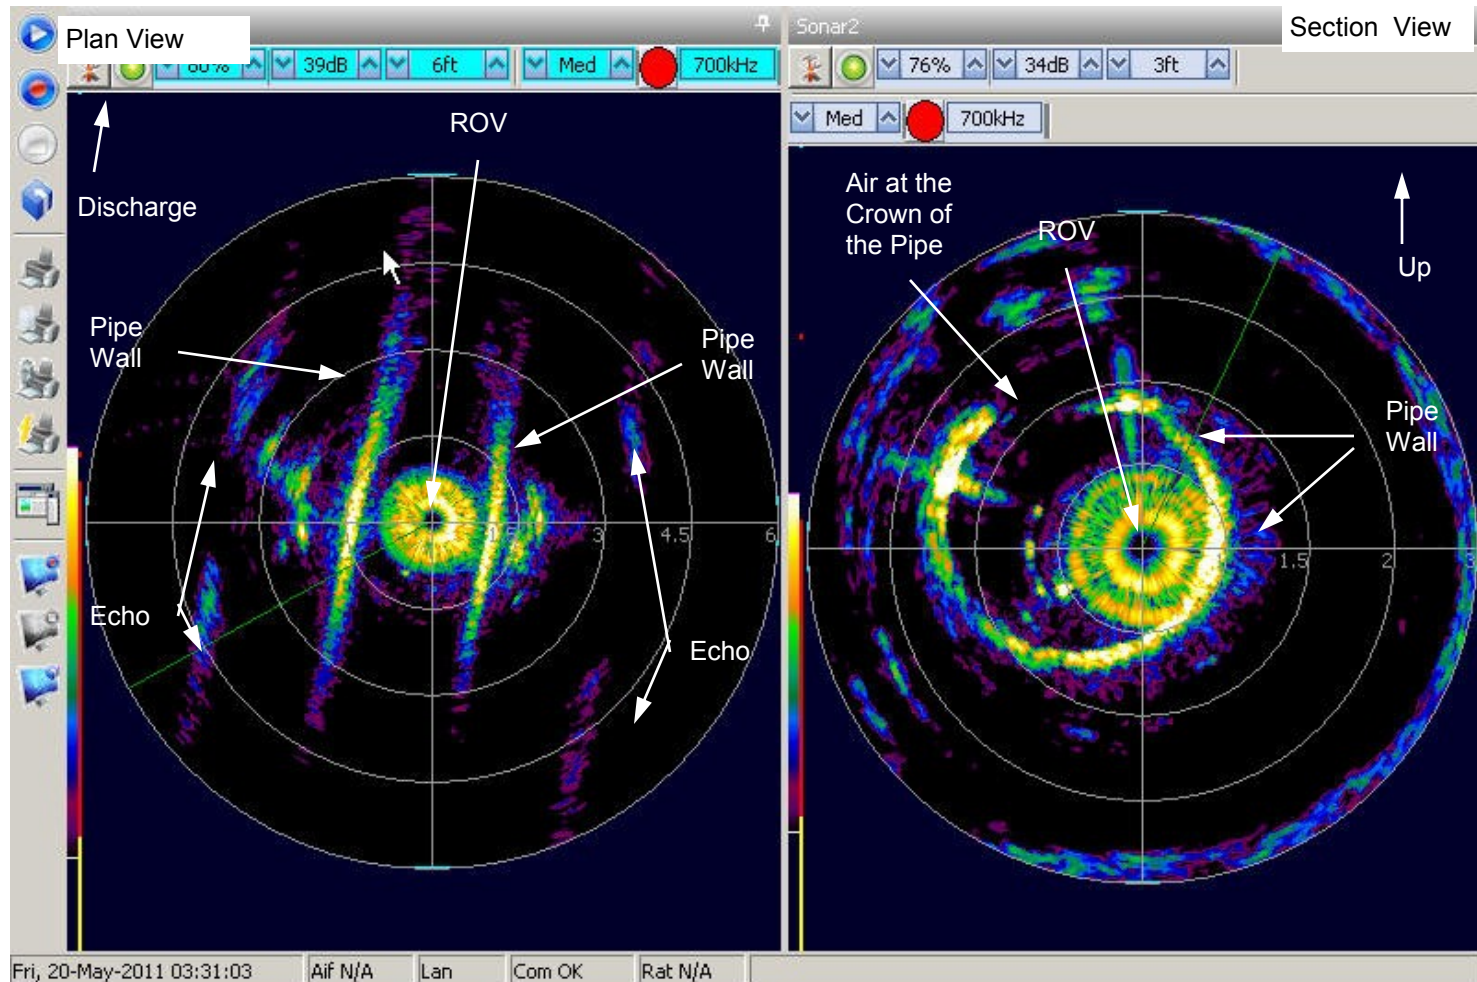
File Name: Morro036.jpg
Tether payout: 800 feet

Notes: Air at the crown of the pipe is producing a reflection and a black spot in the plot.

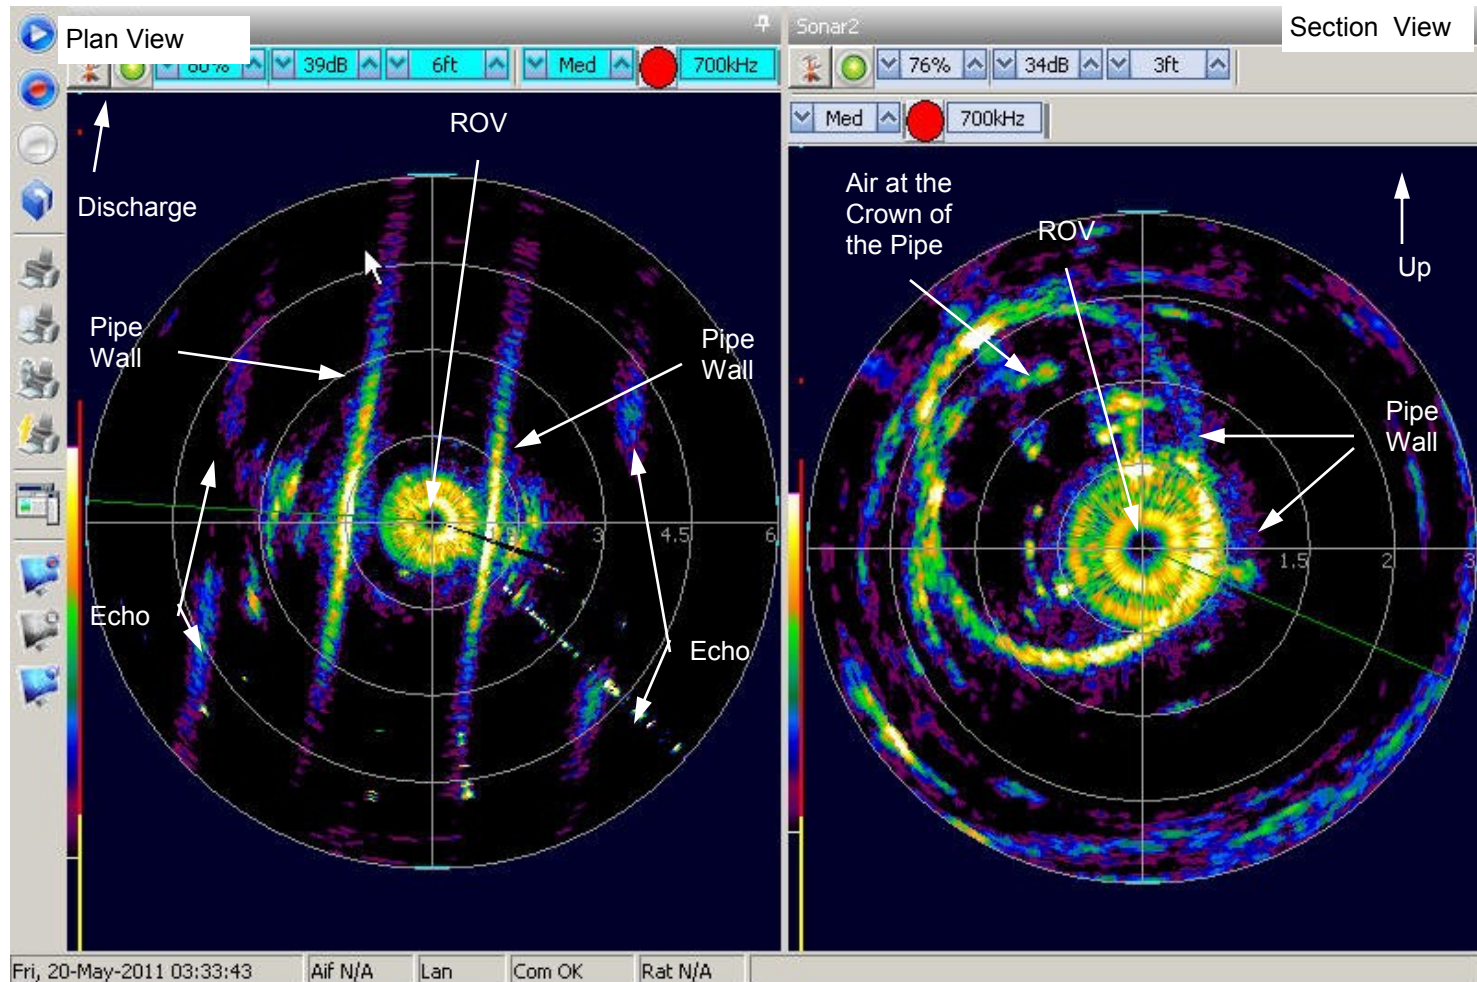
File Name: Morro037.jpg
Tether payout: 700 feet

Notes: Air in the crown of the pipe is causing a reflection of the data. The pipe is round as confirmed with video.

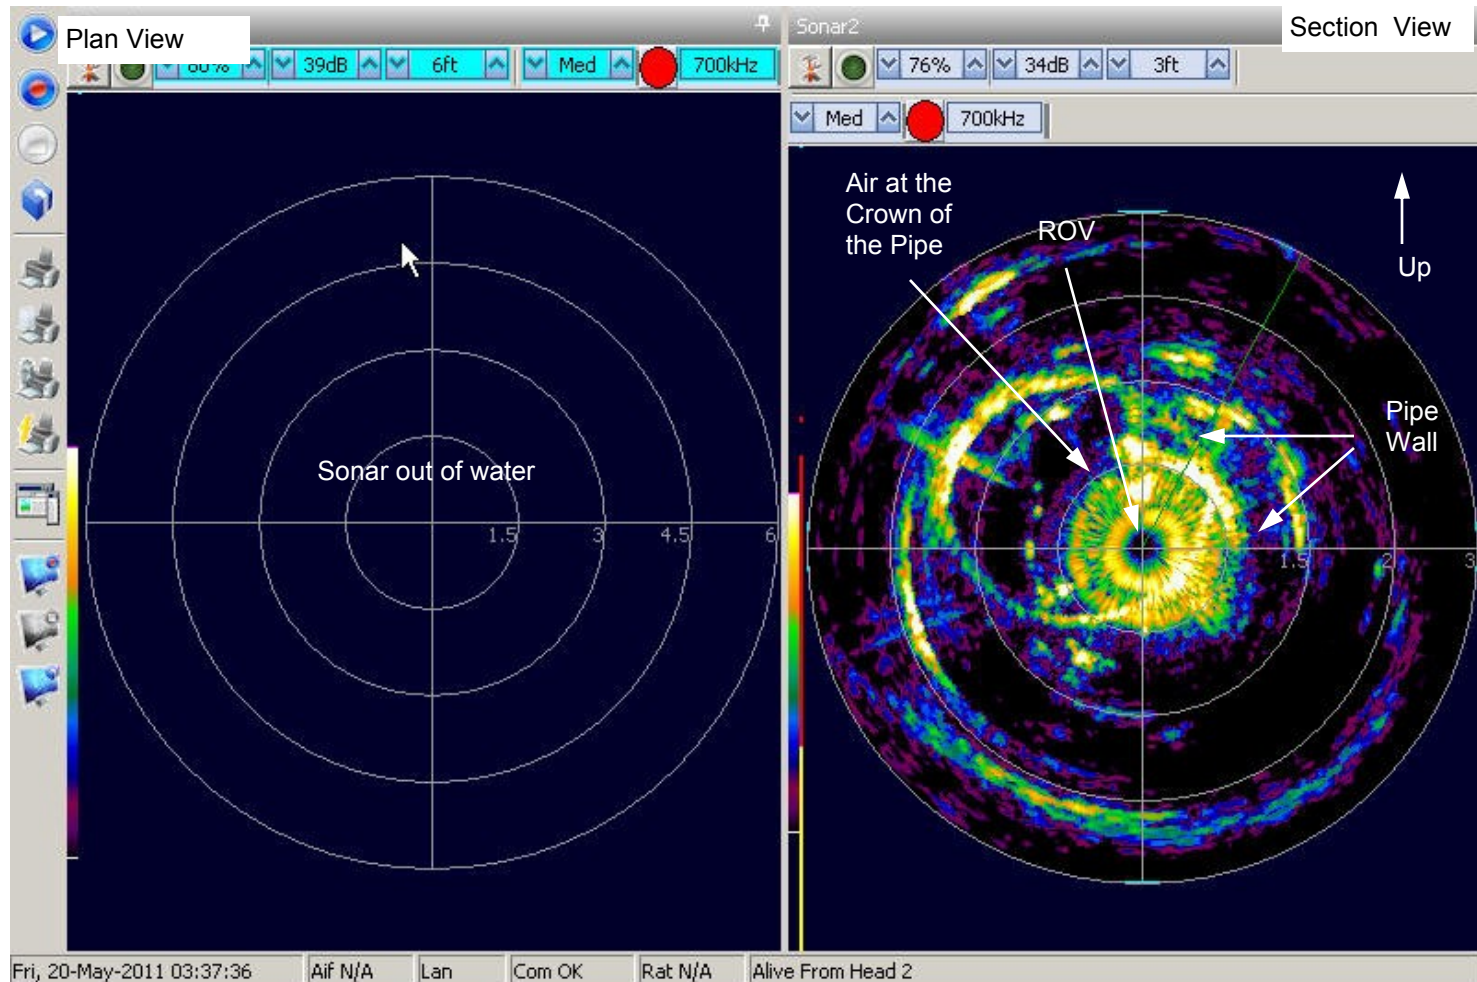
File Name: Morro038.jpg
Tether payout: 600 feet

Notes: Air in the crown of the pipe is causing a reflection of the data. The pipe is round as confirmed with video. End of sonar for inspection, both sonars out of water beyond this position.
