City of Morro Bay
Water Reclamation Facility Project

OUTFALL ASSESSMENT PLAN

DRAFT | March 2020

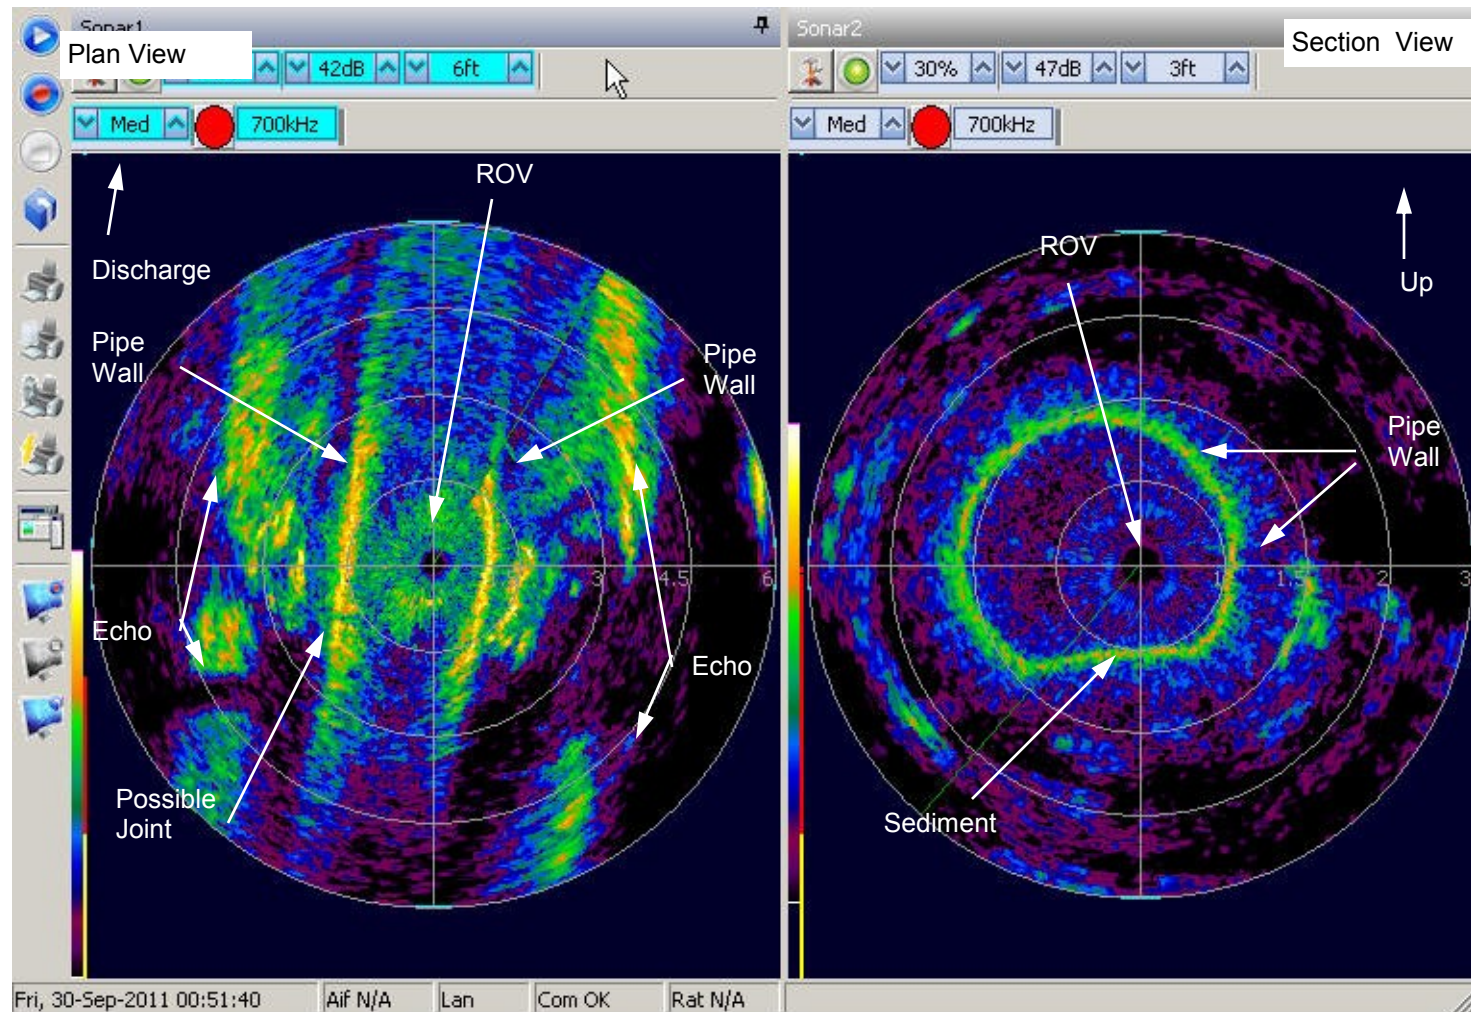
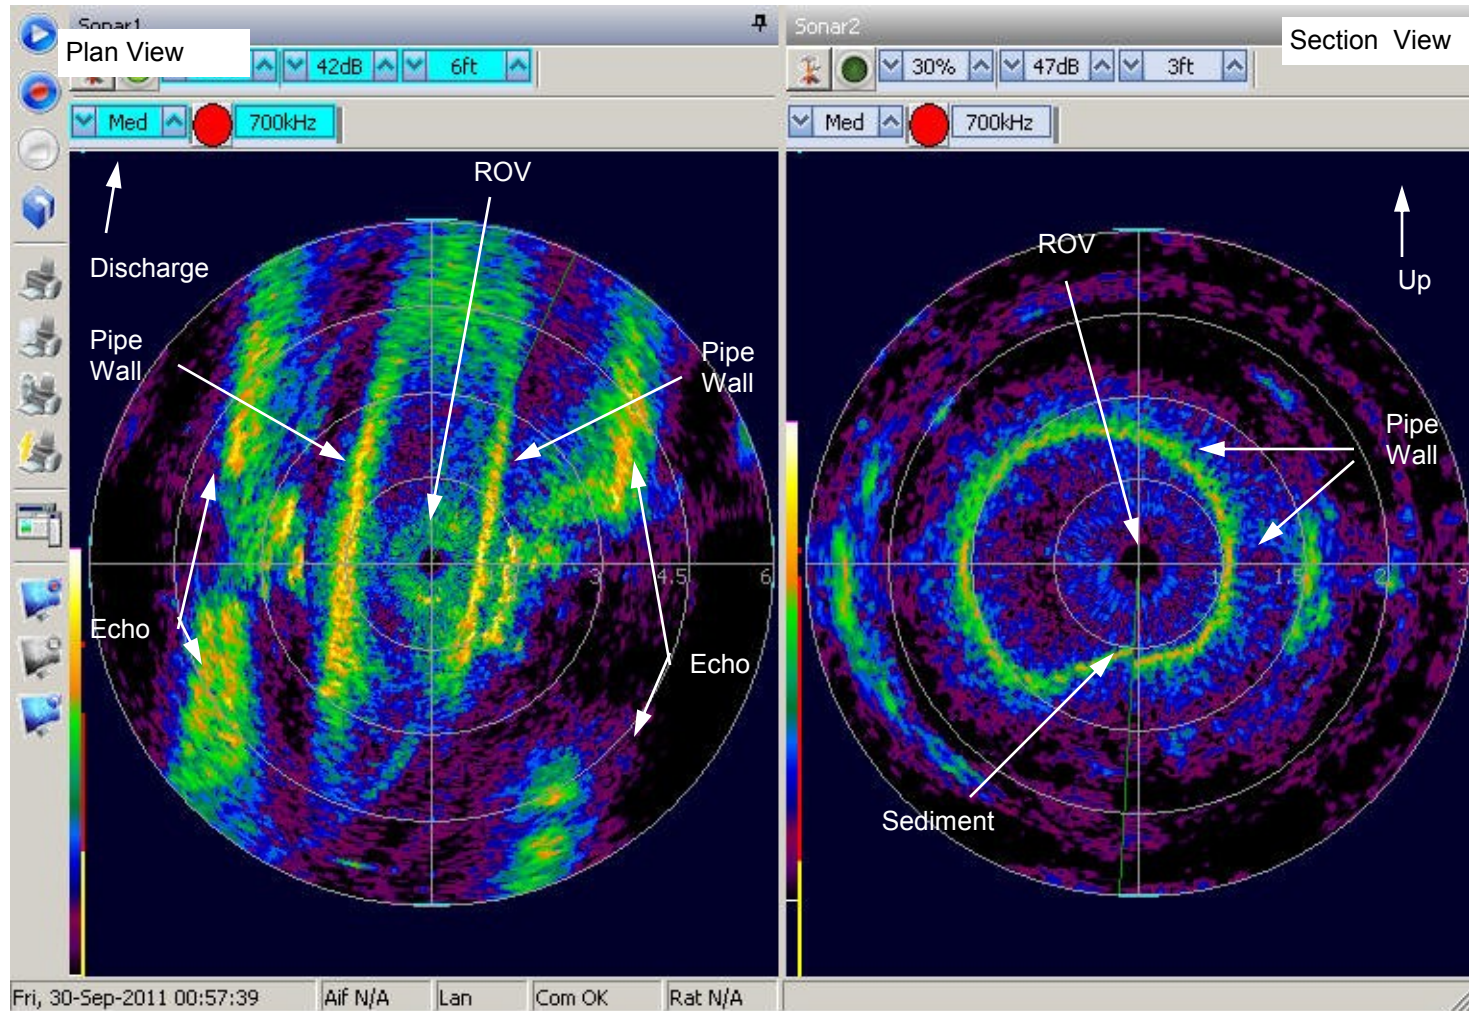
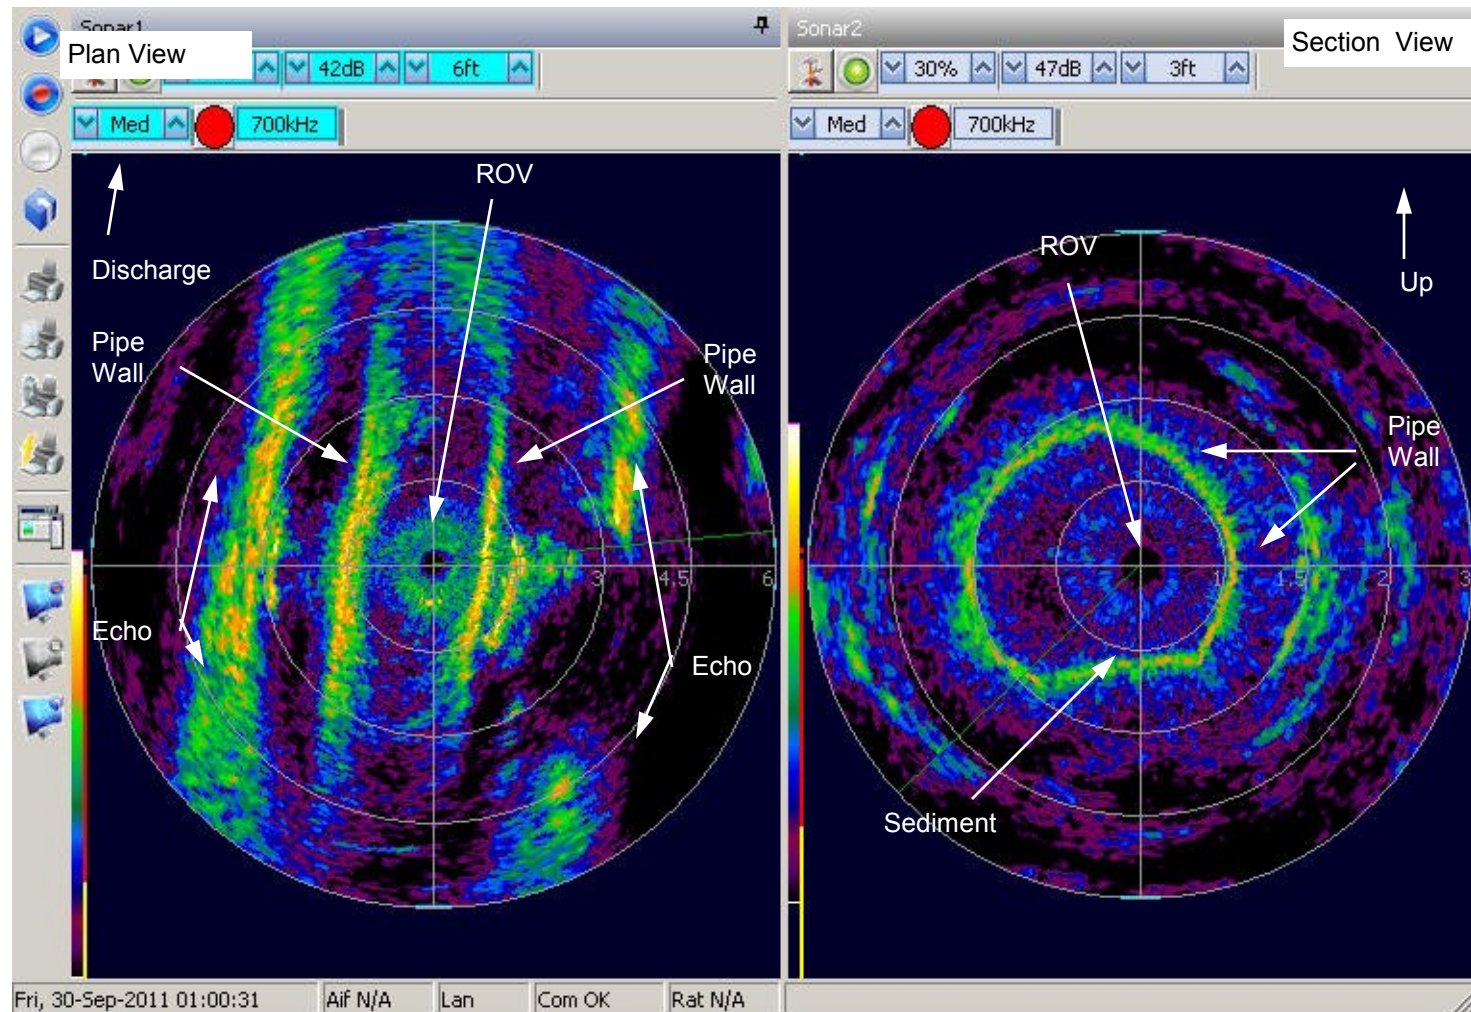
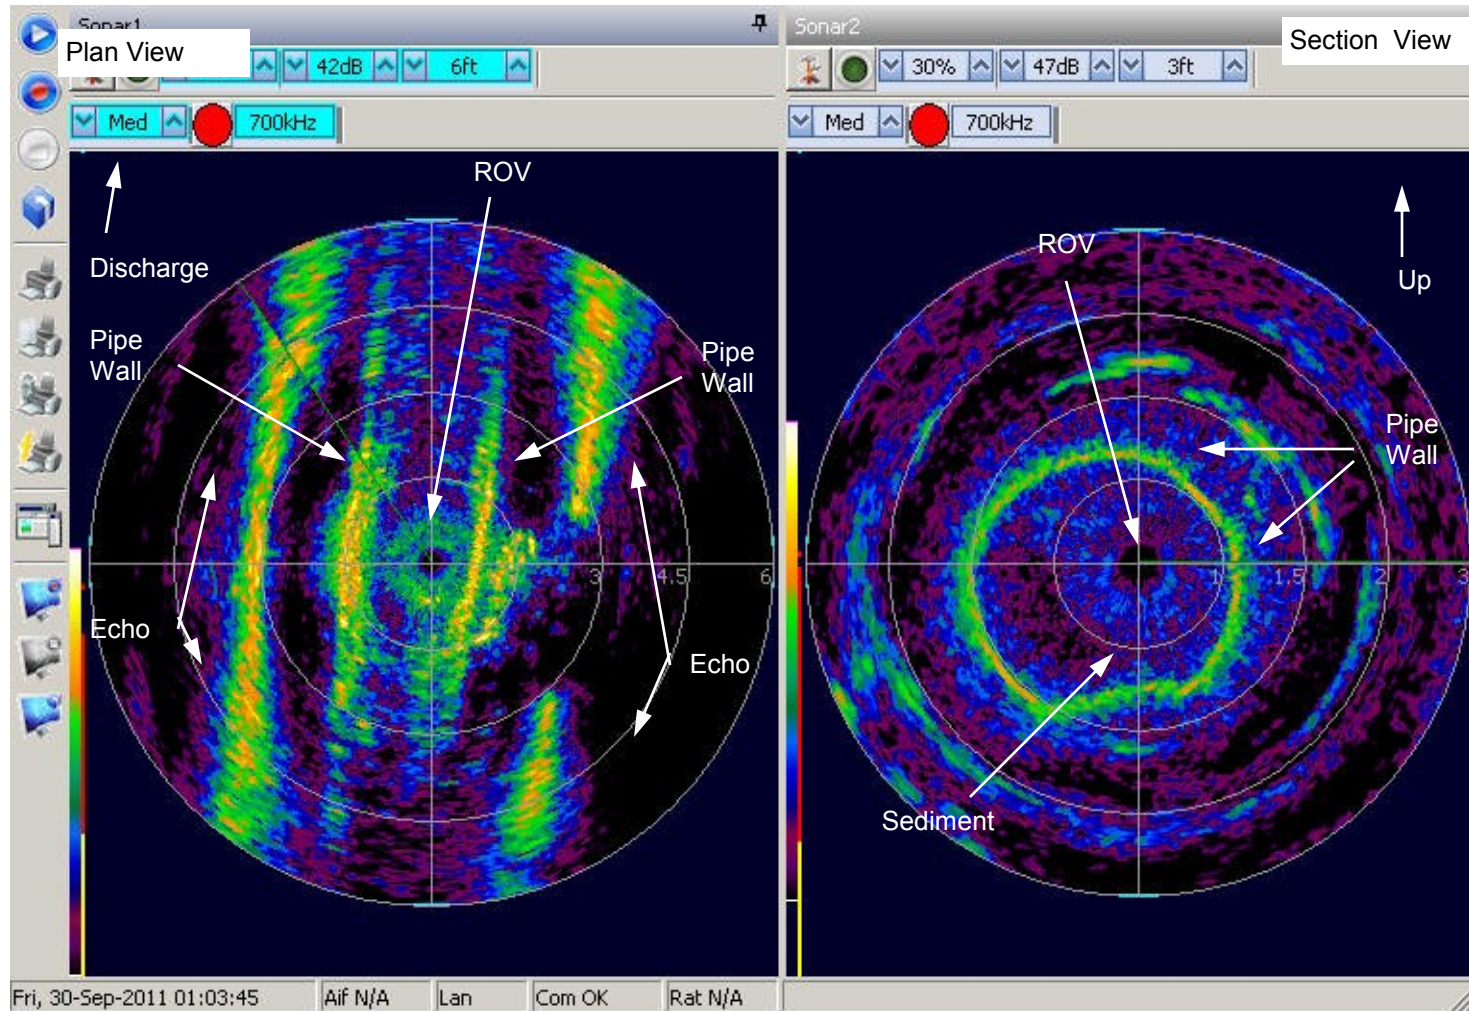
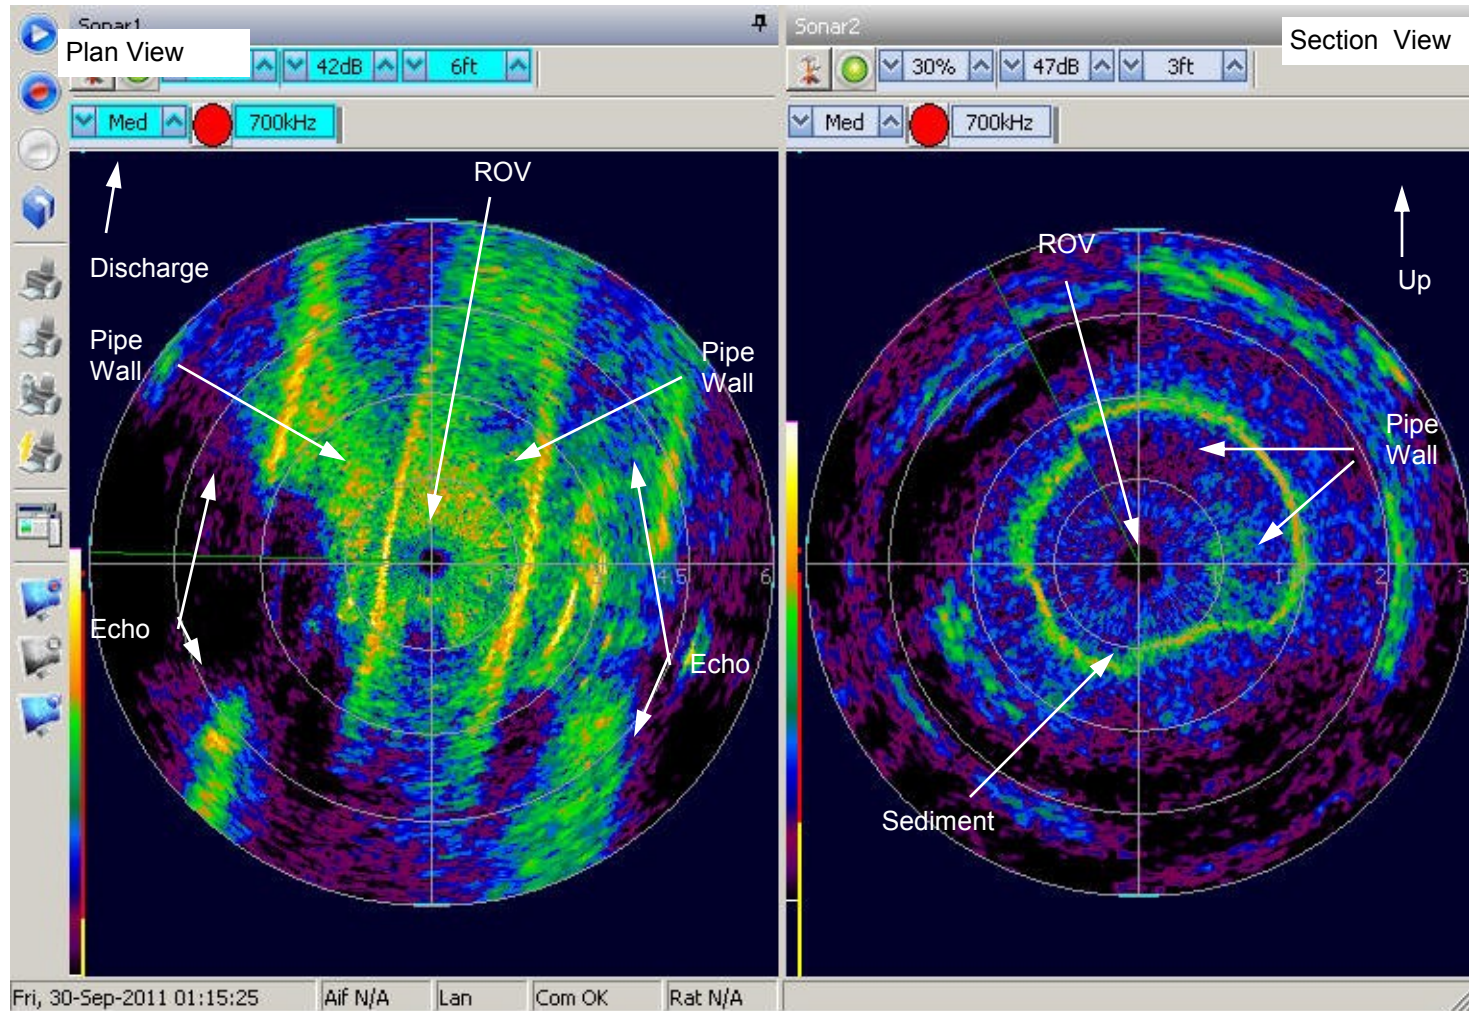
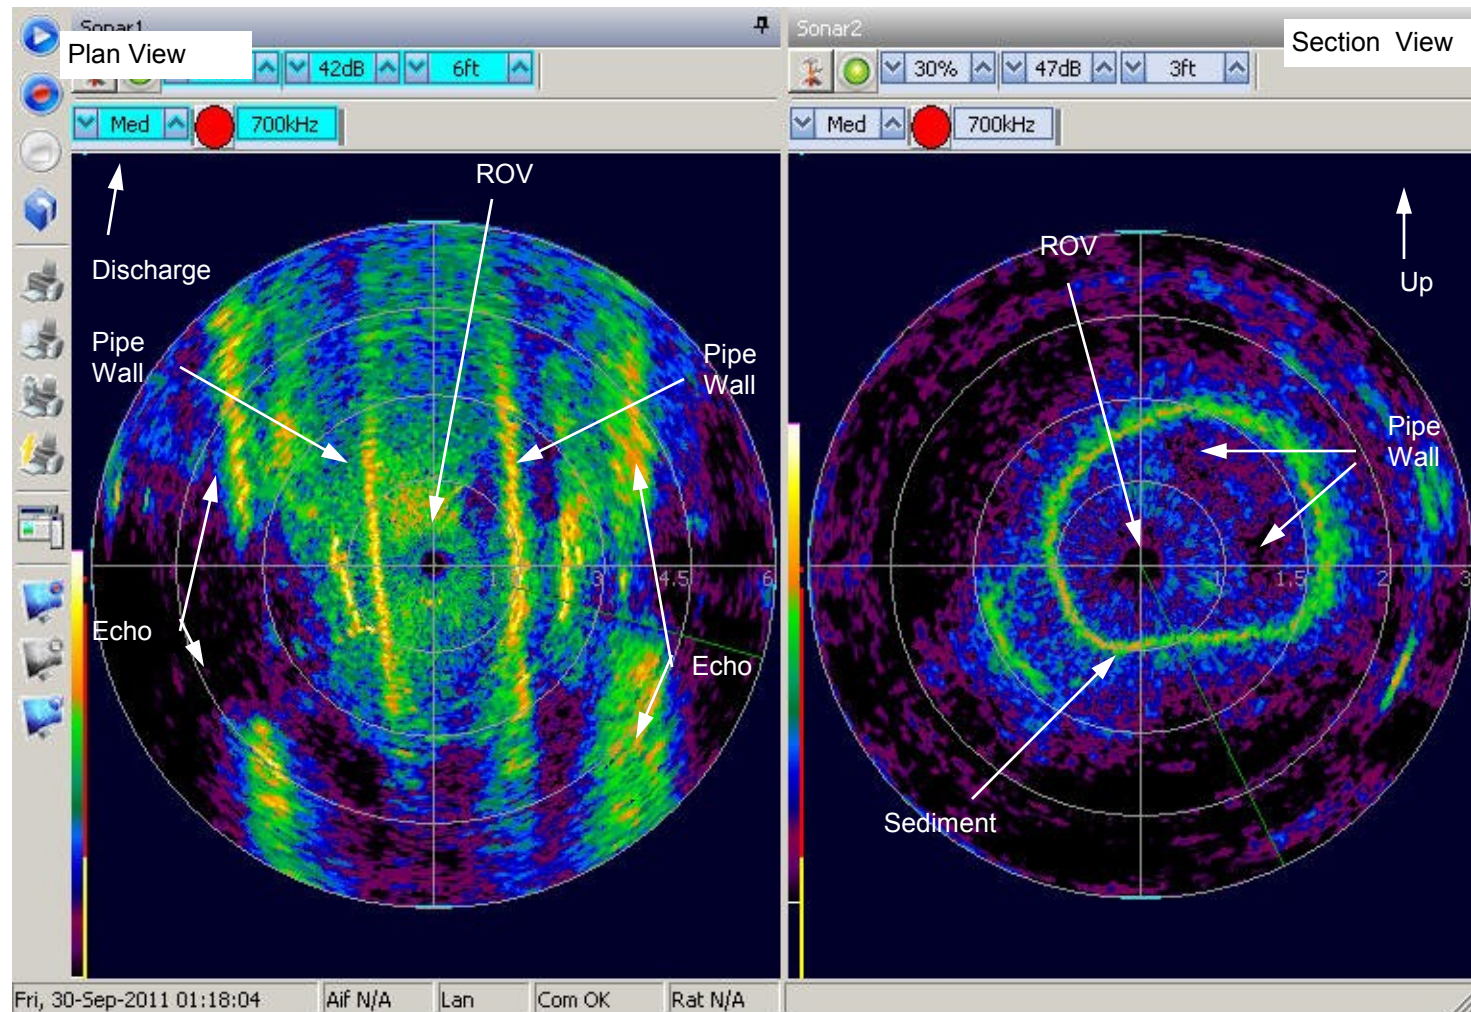
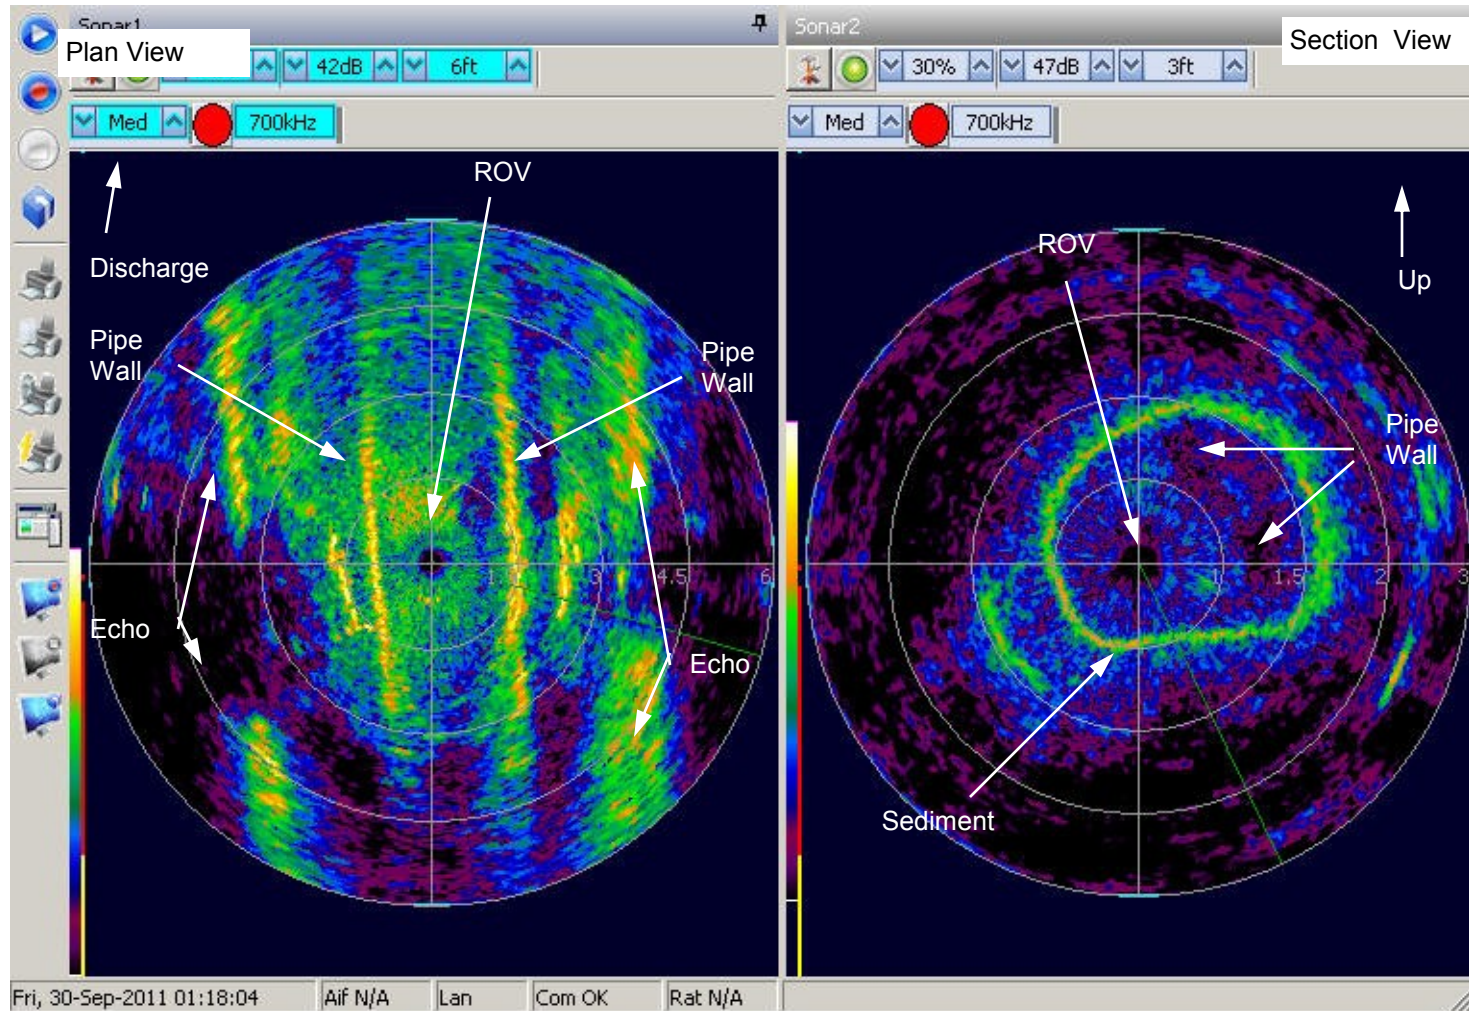
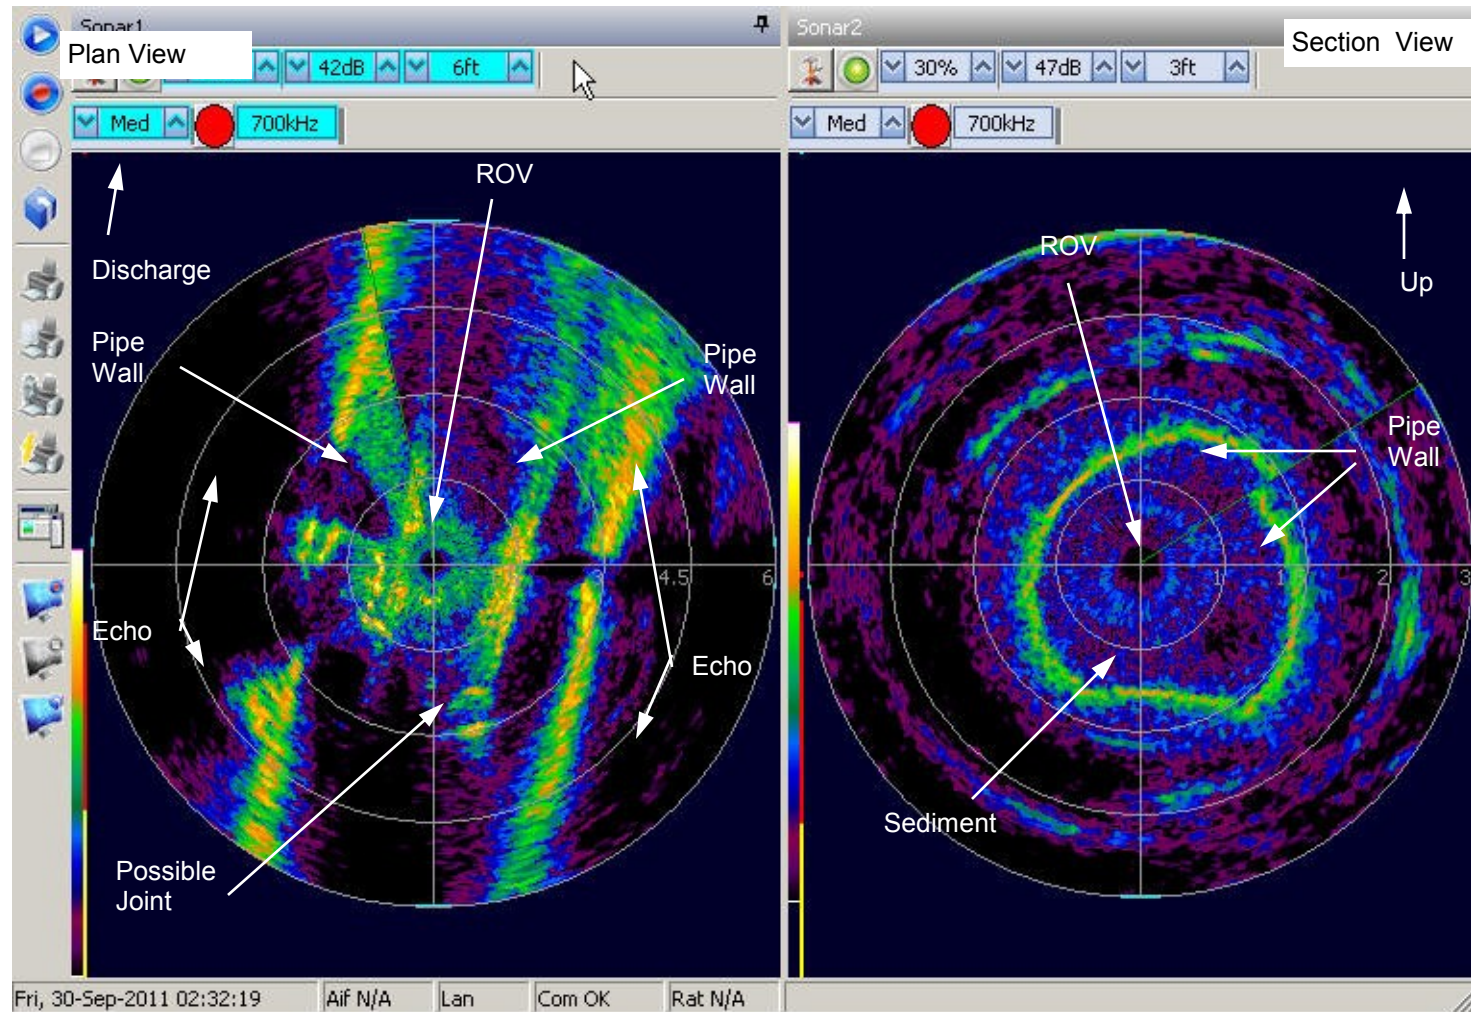
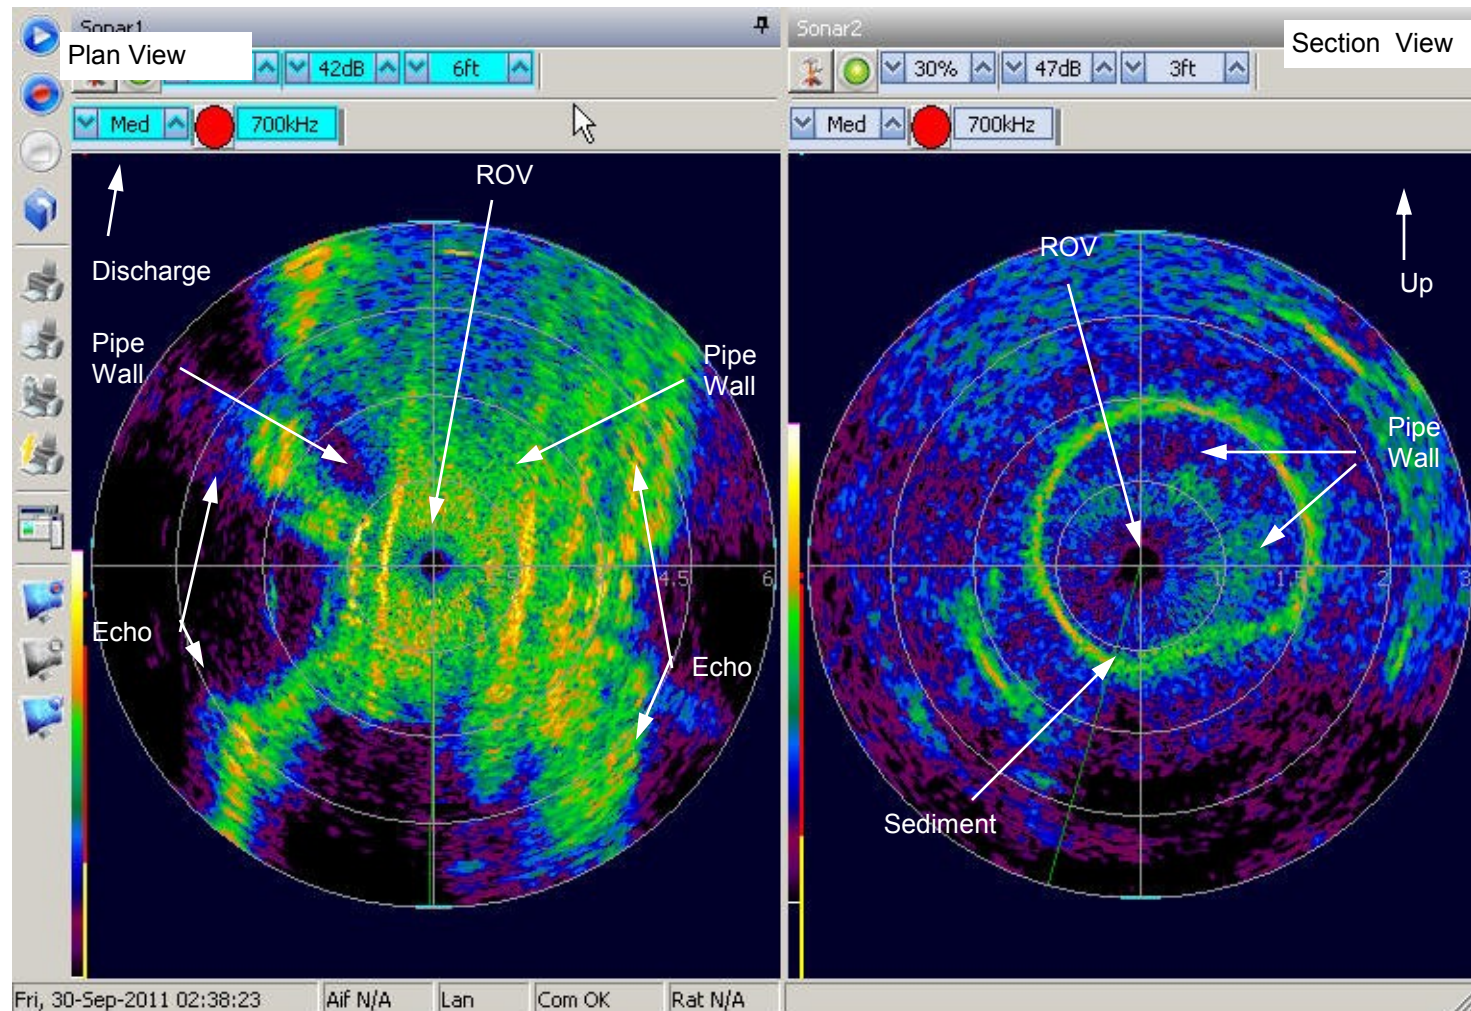
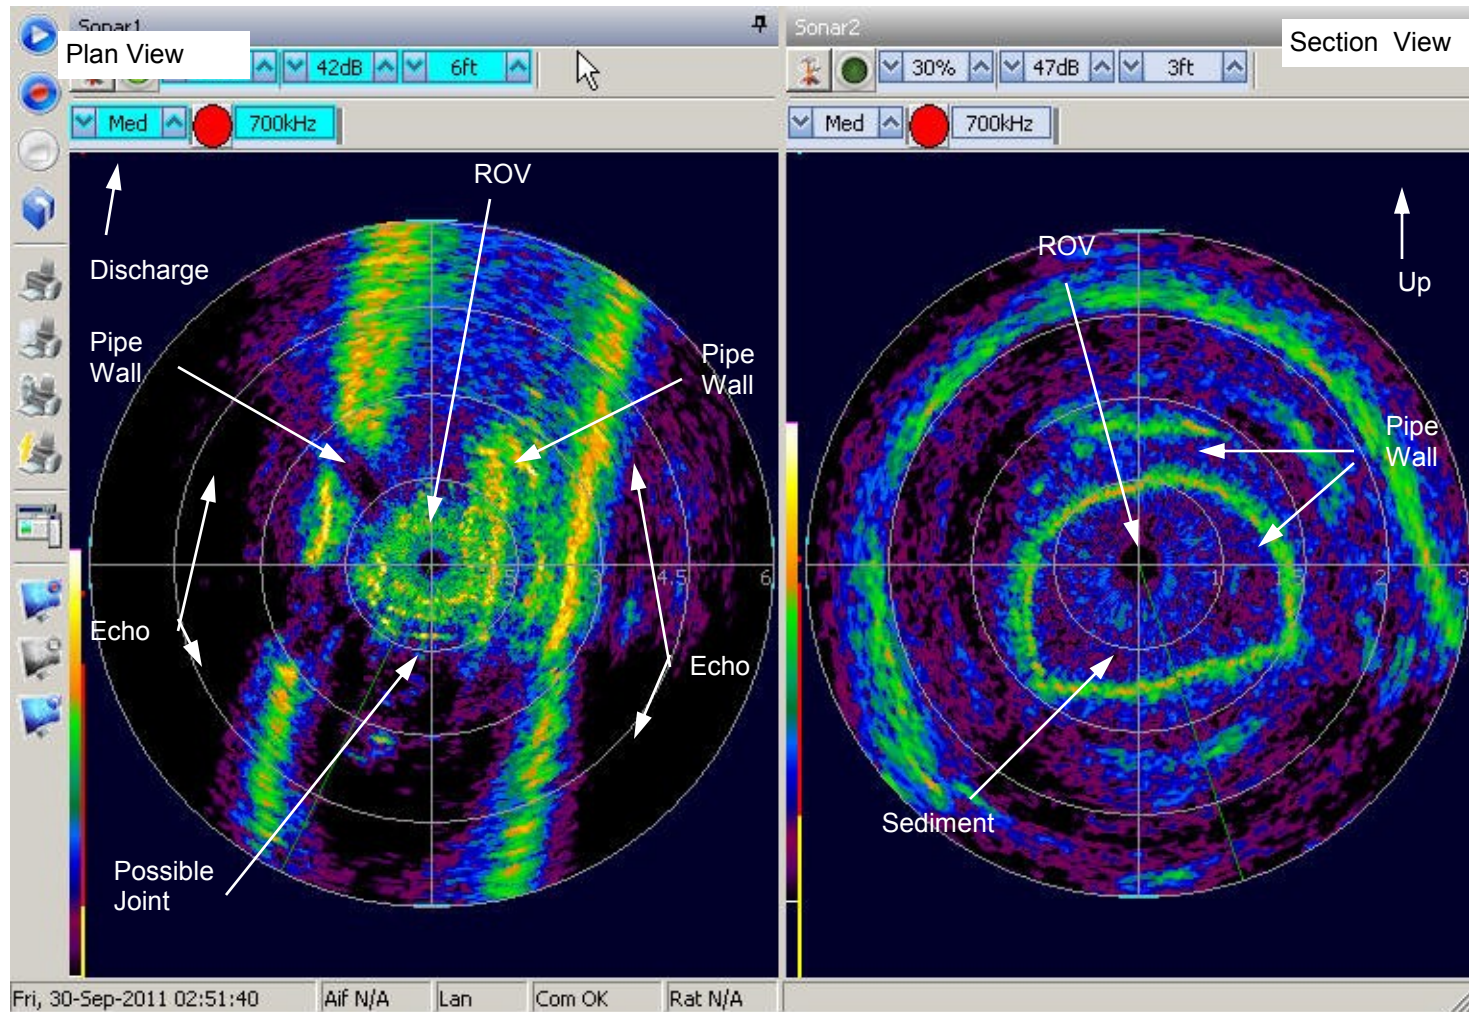
Notes: Approximately 2" of sediment.
