City of Morro Bay
Water Reclamation Facility Project

OUTFALL ASSESSMENT PLAN

DRAFT | March 2020

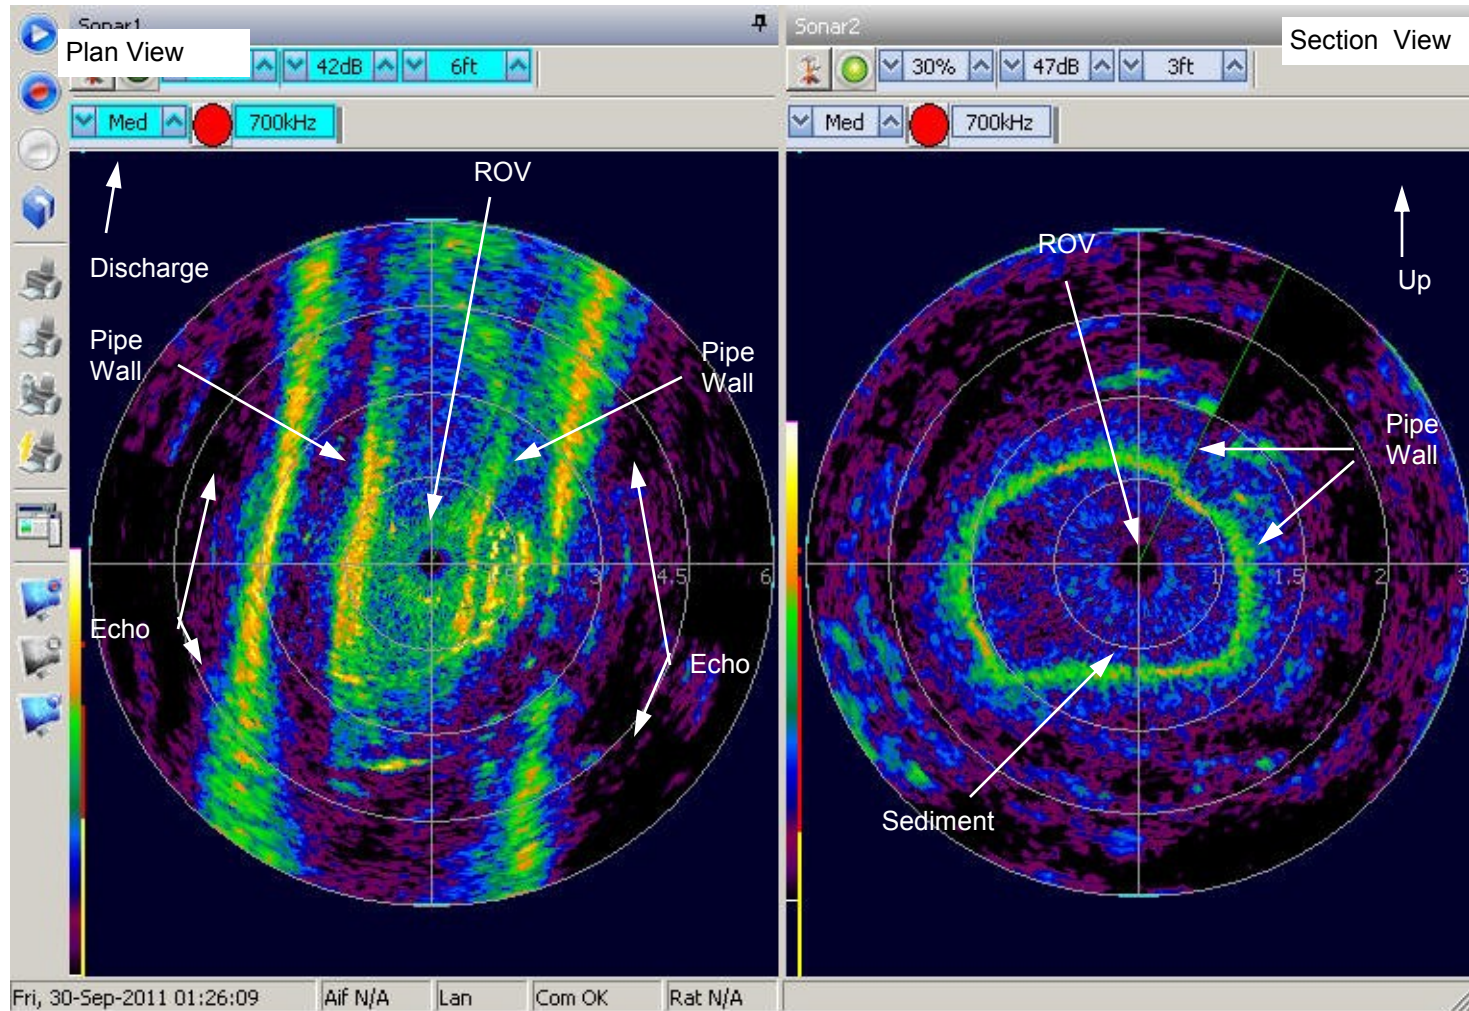
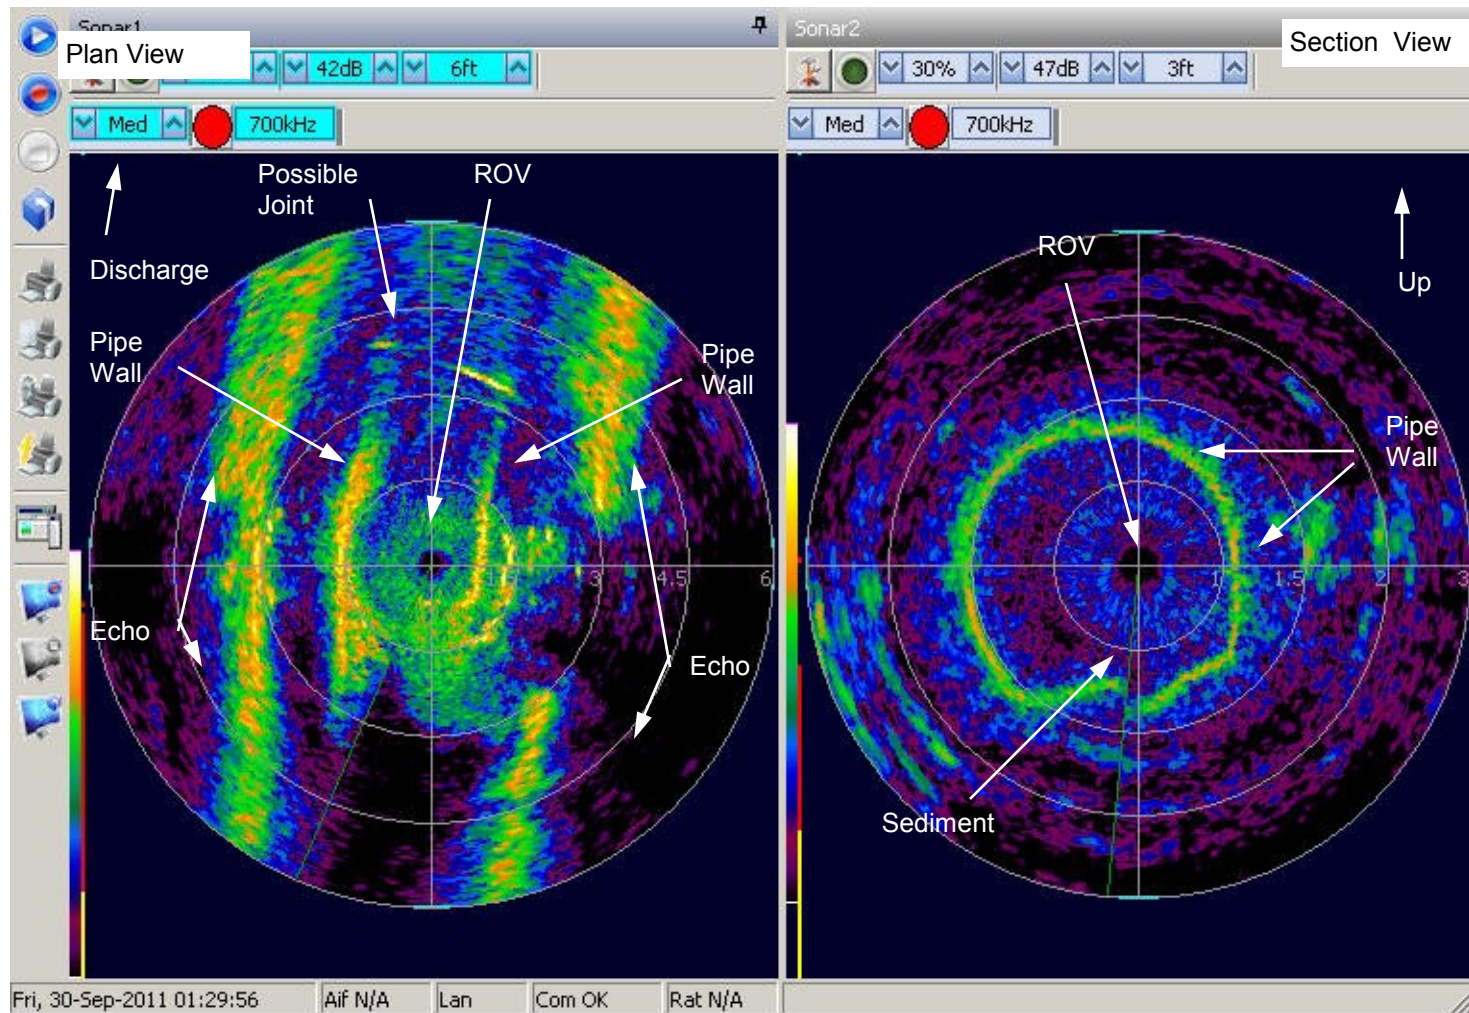
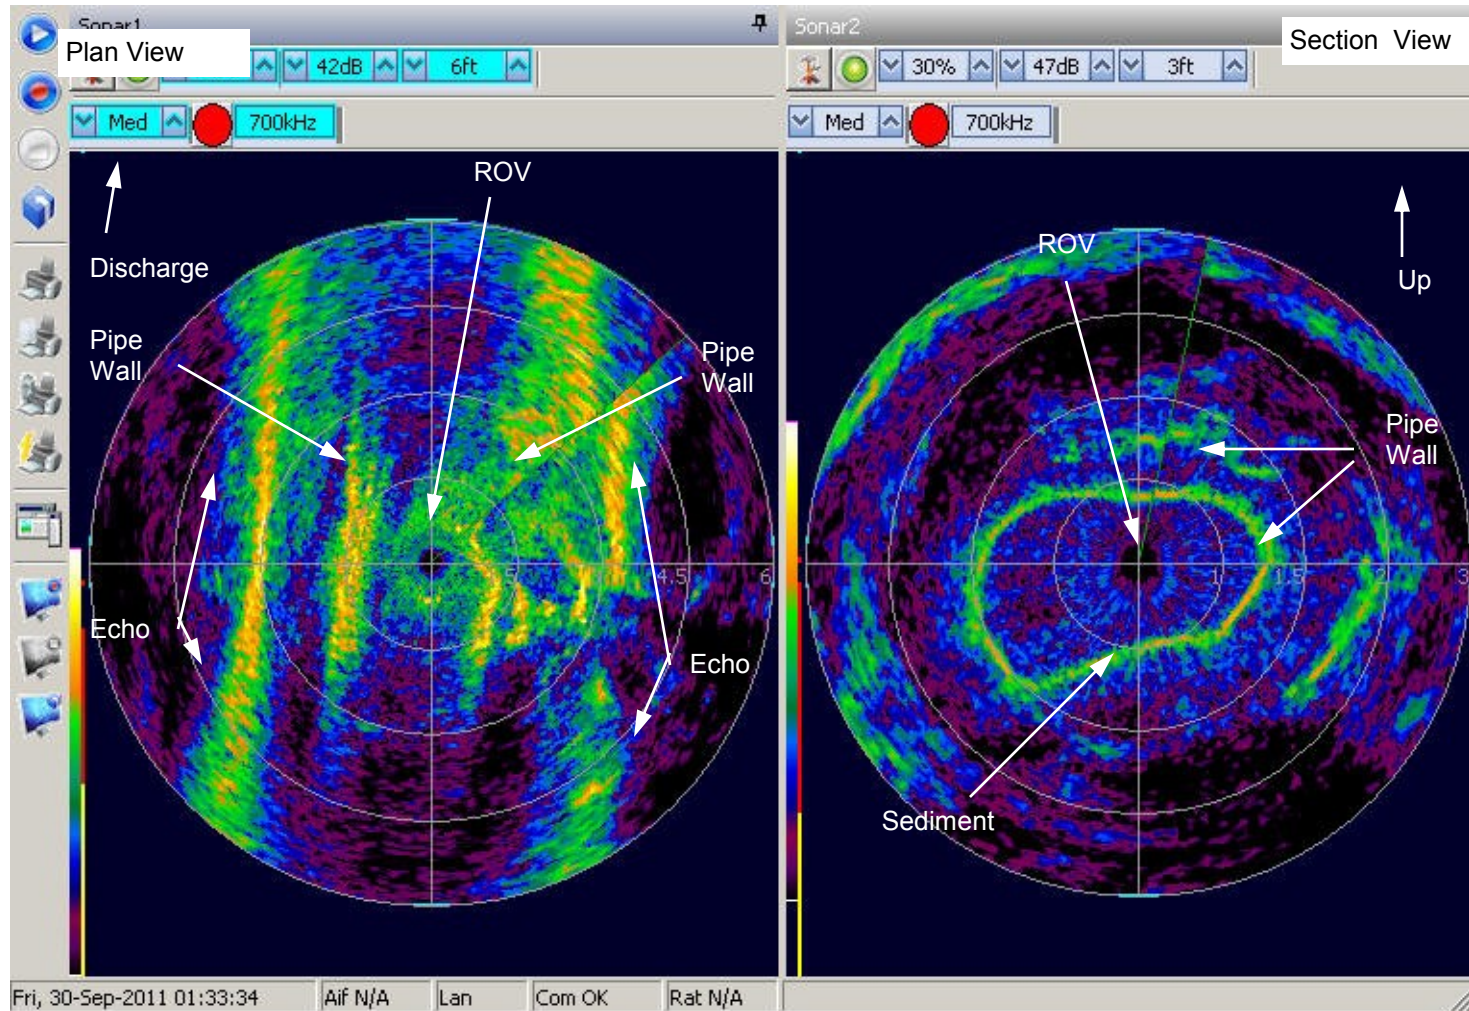
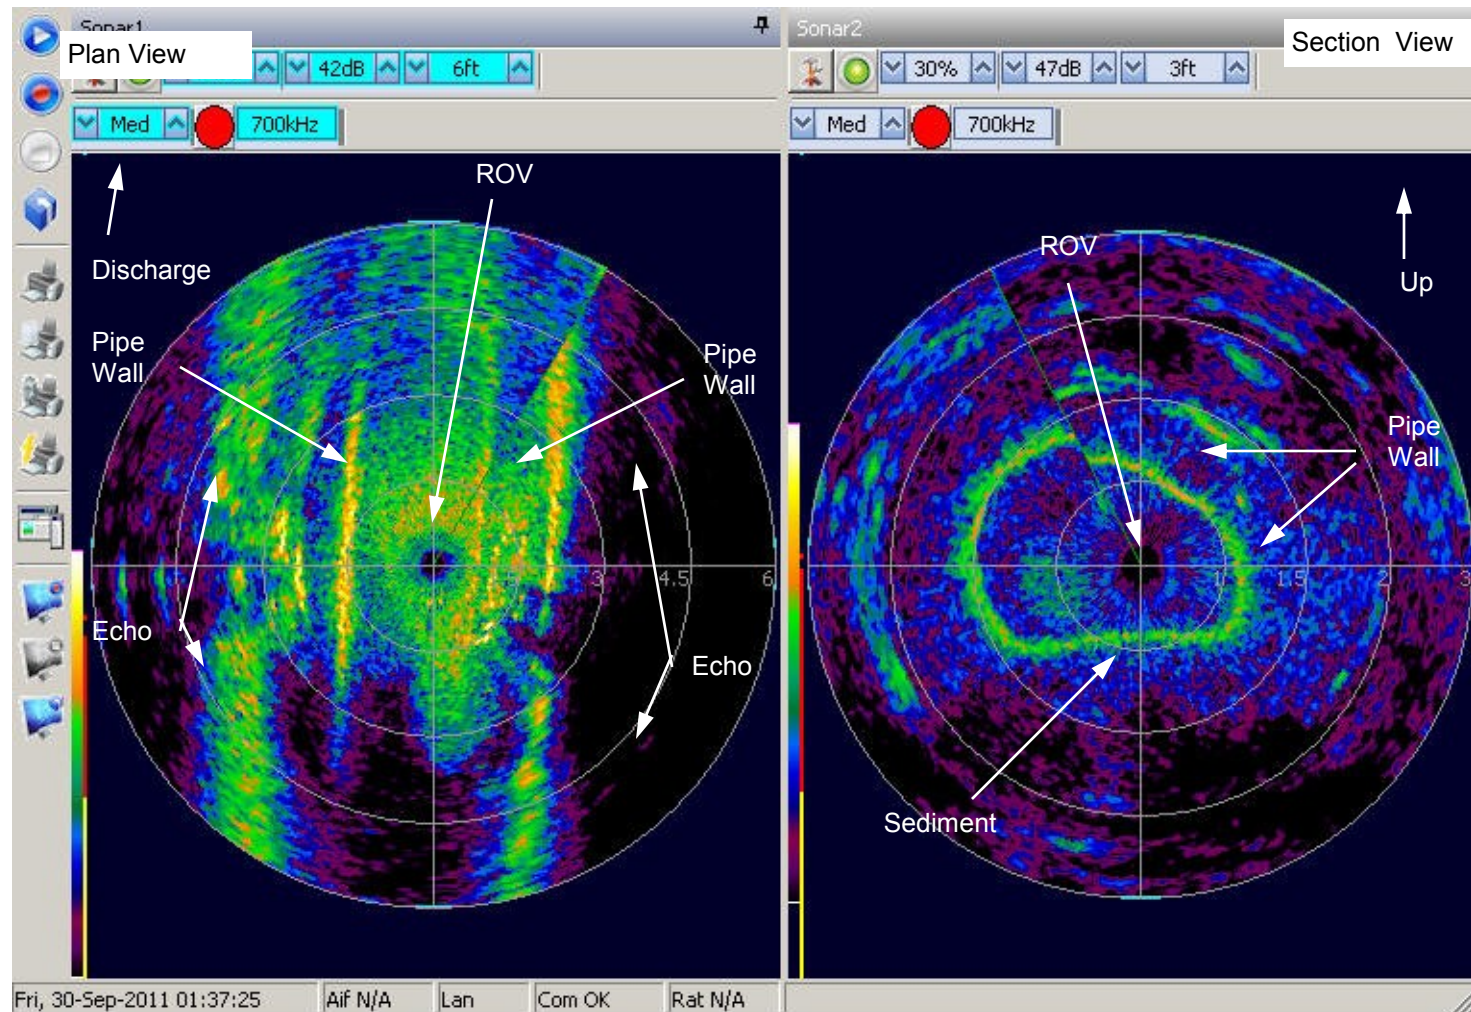
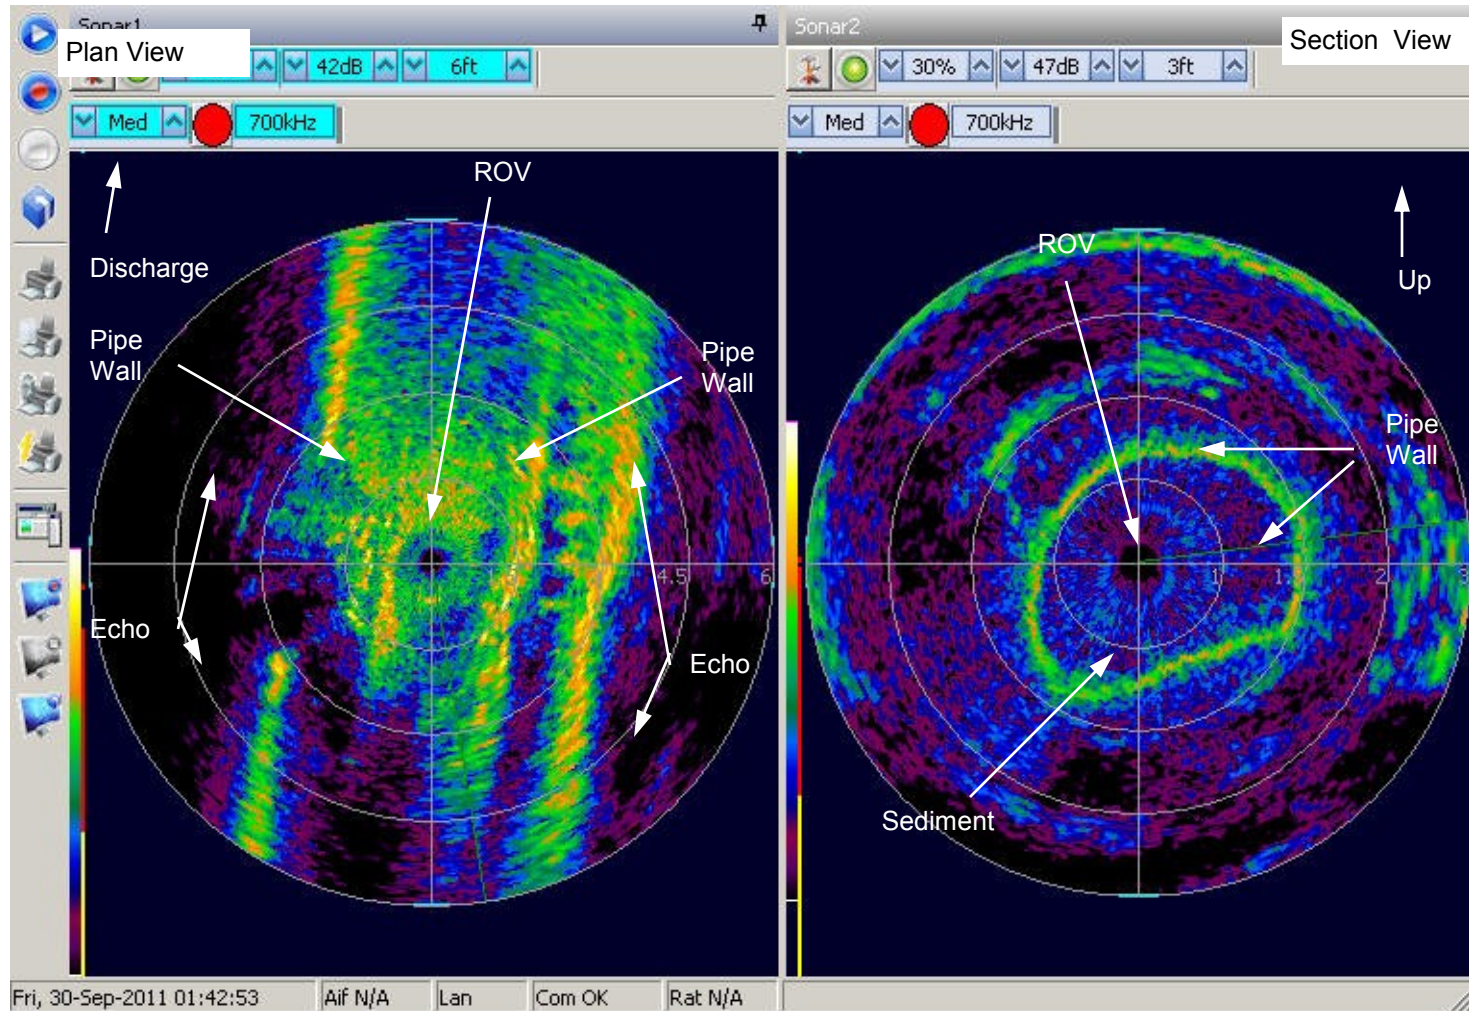
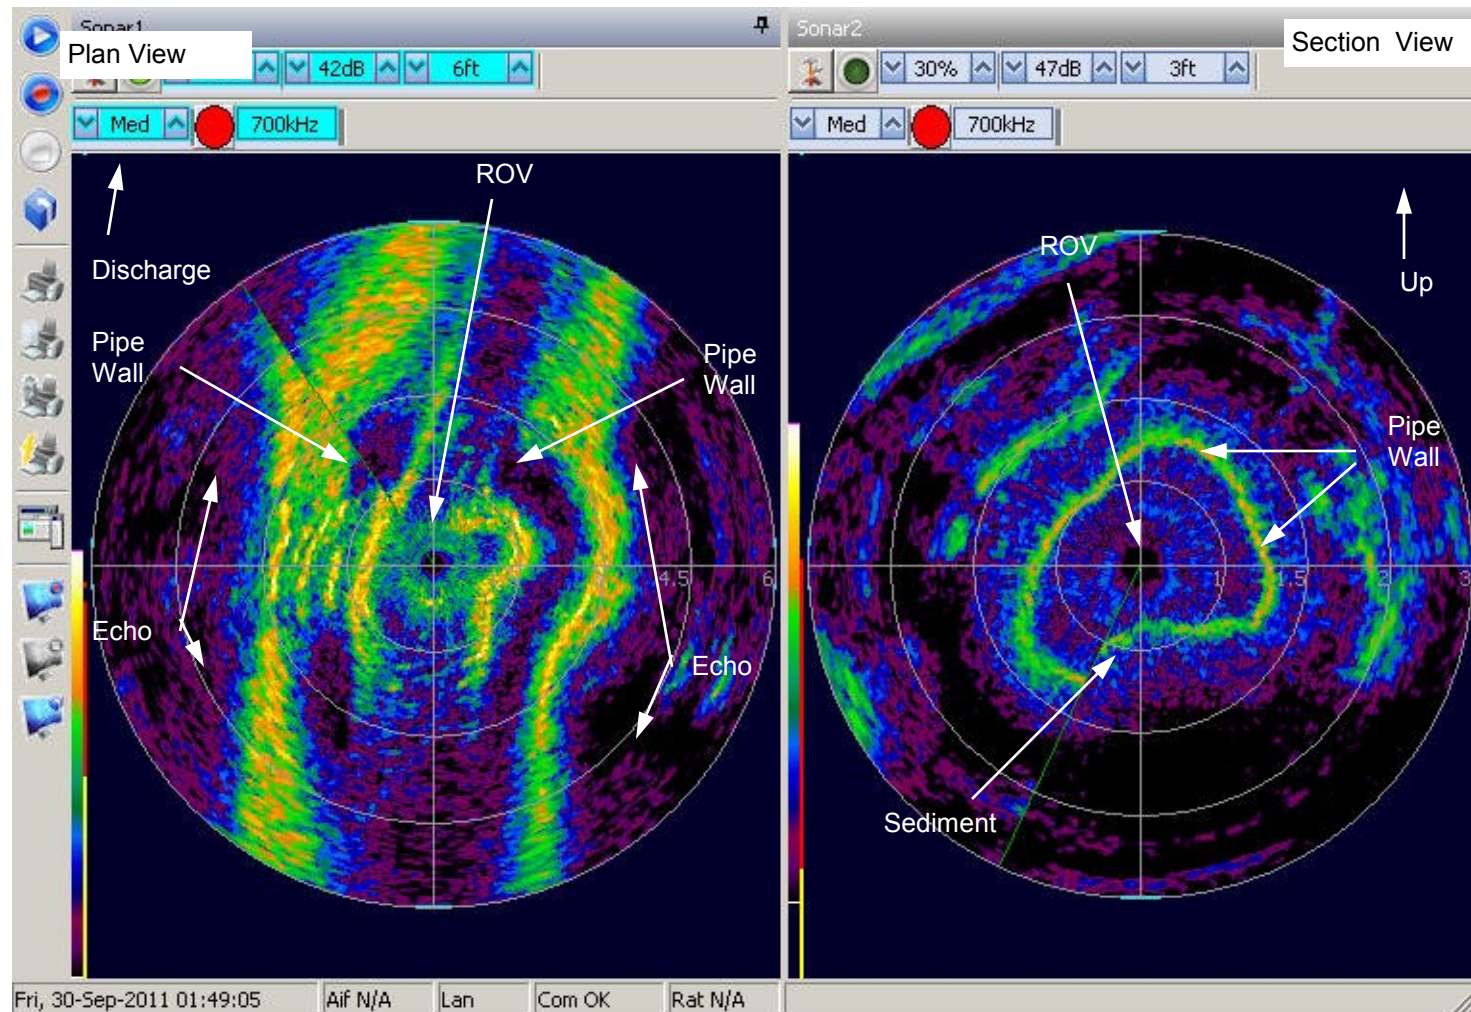
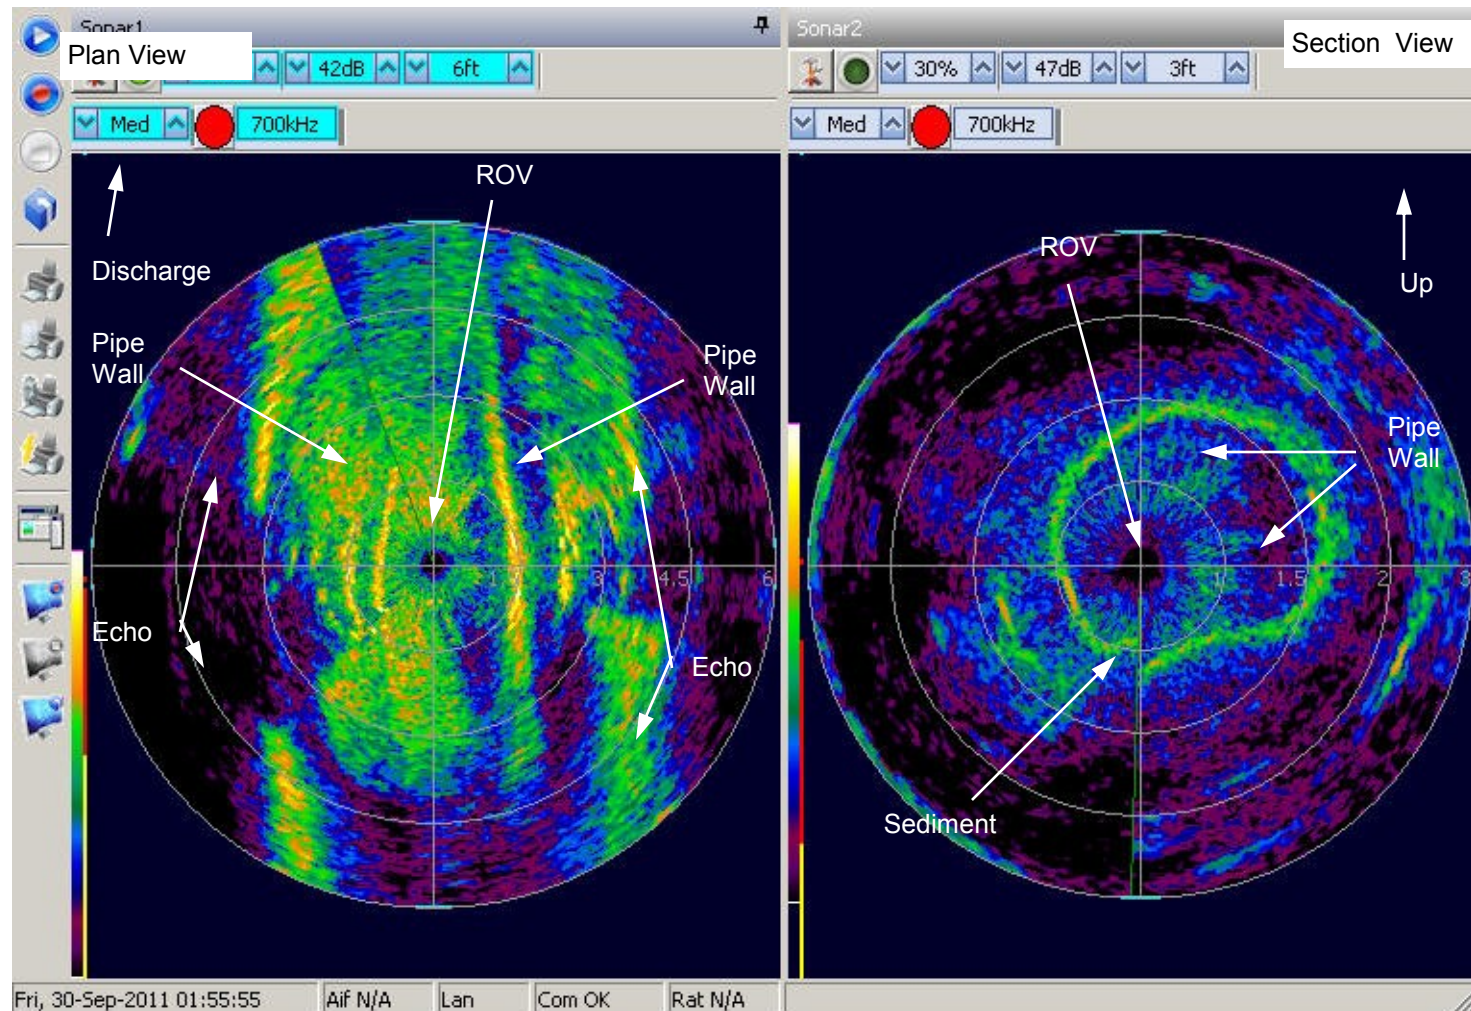
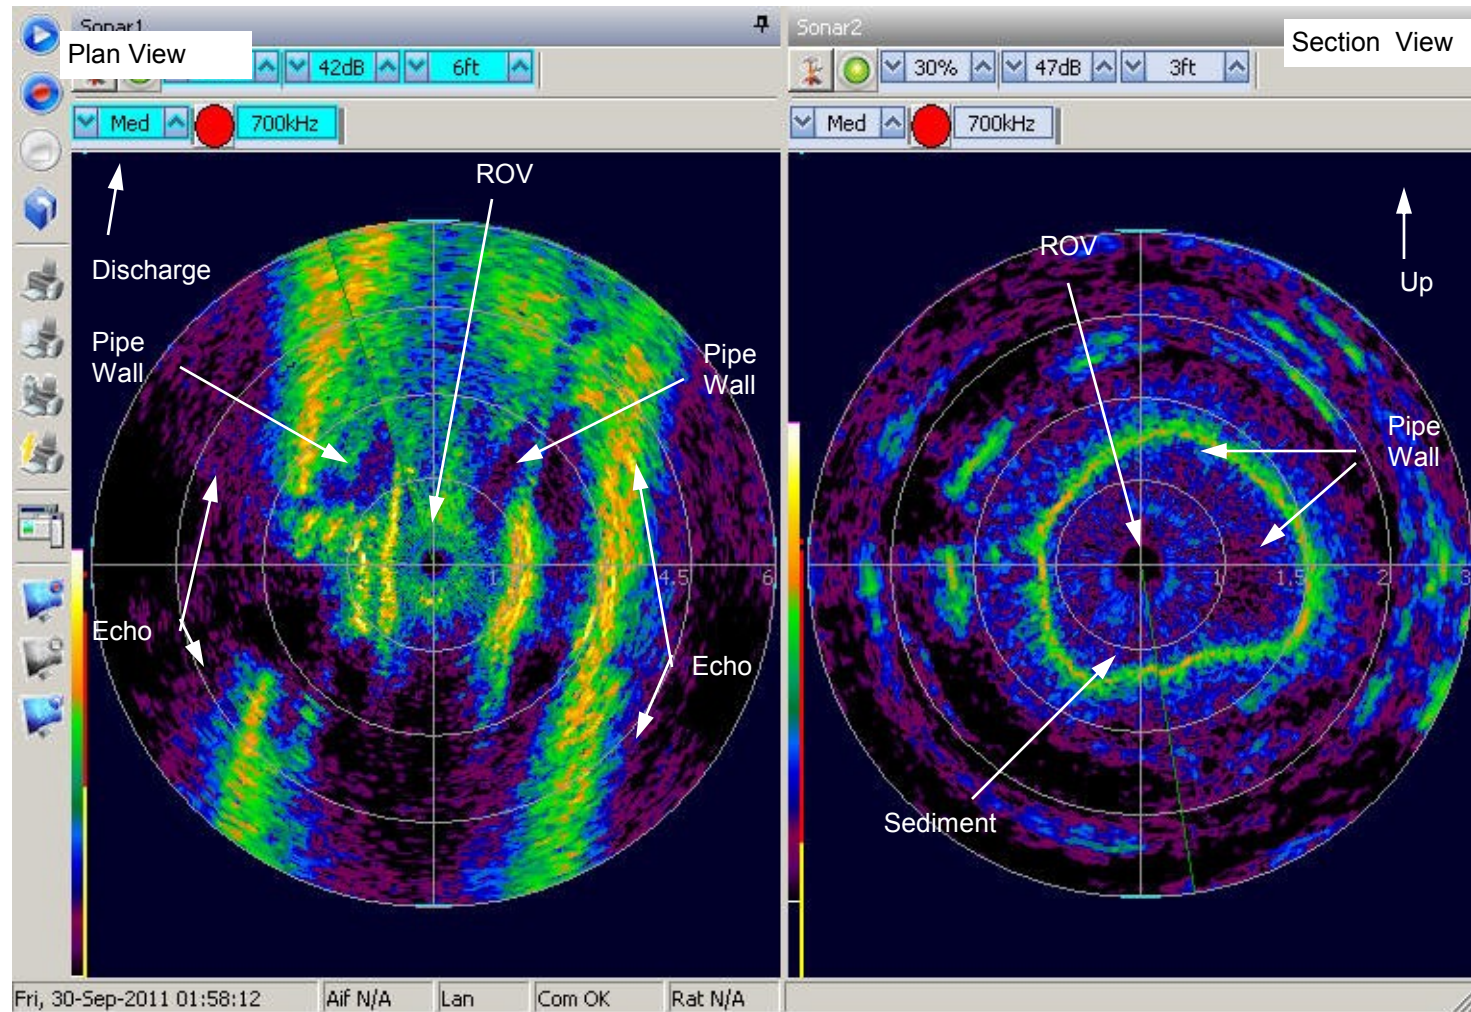
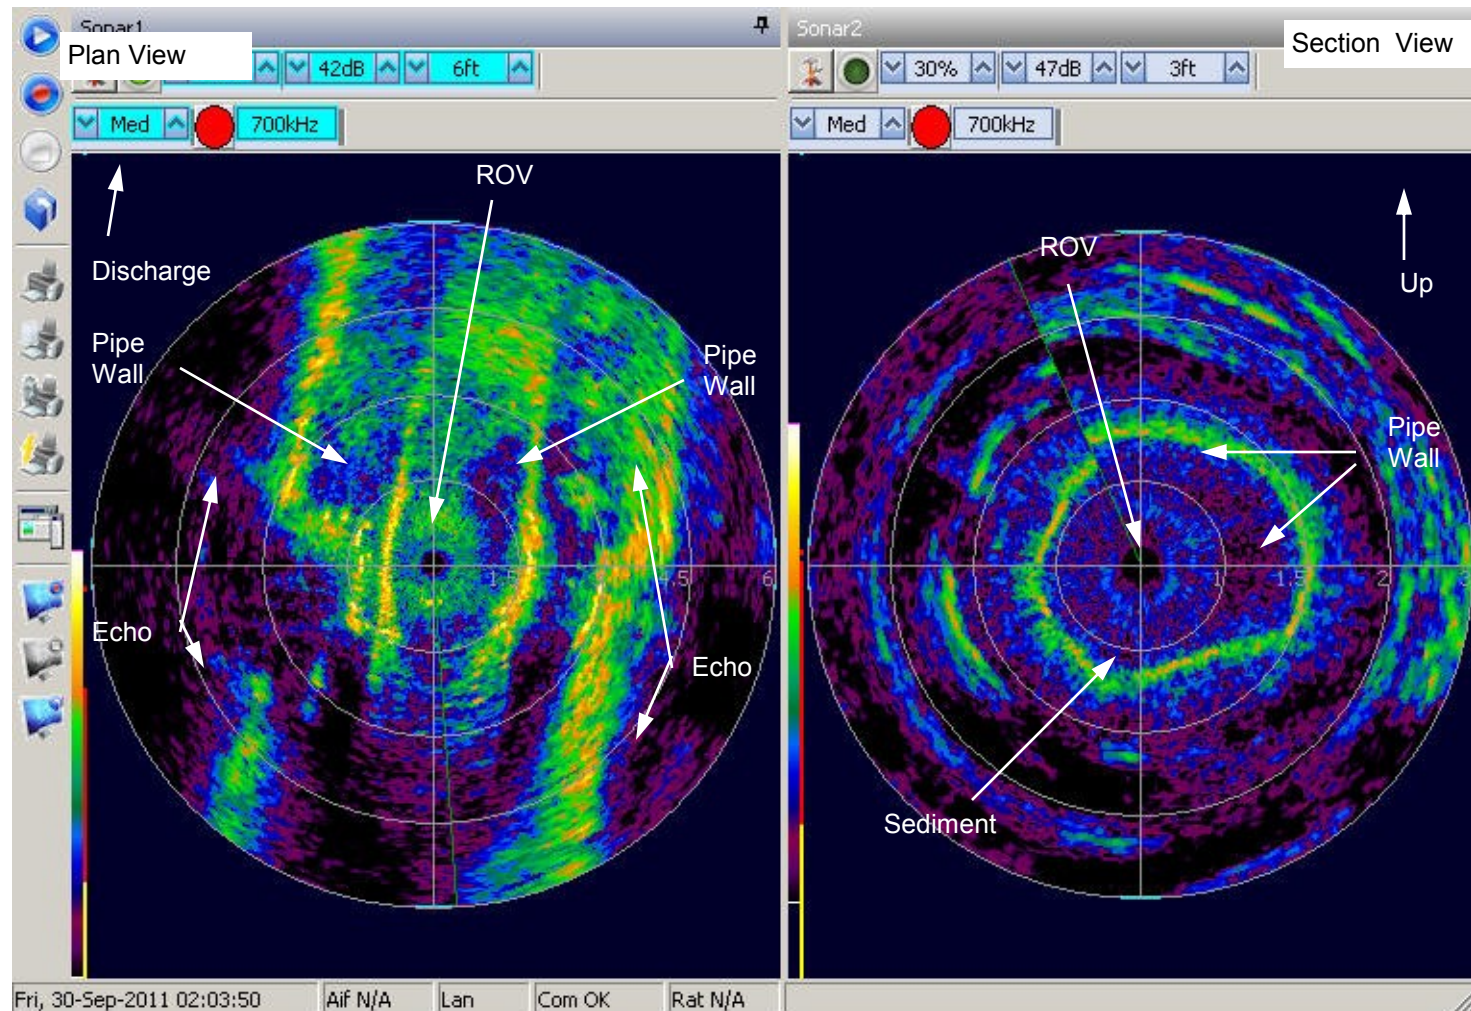
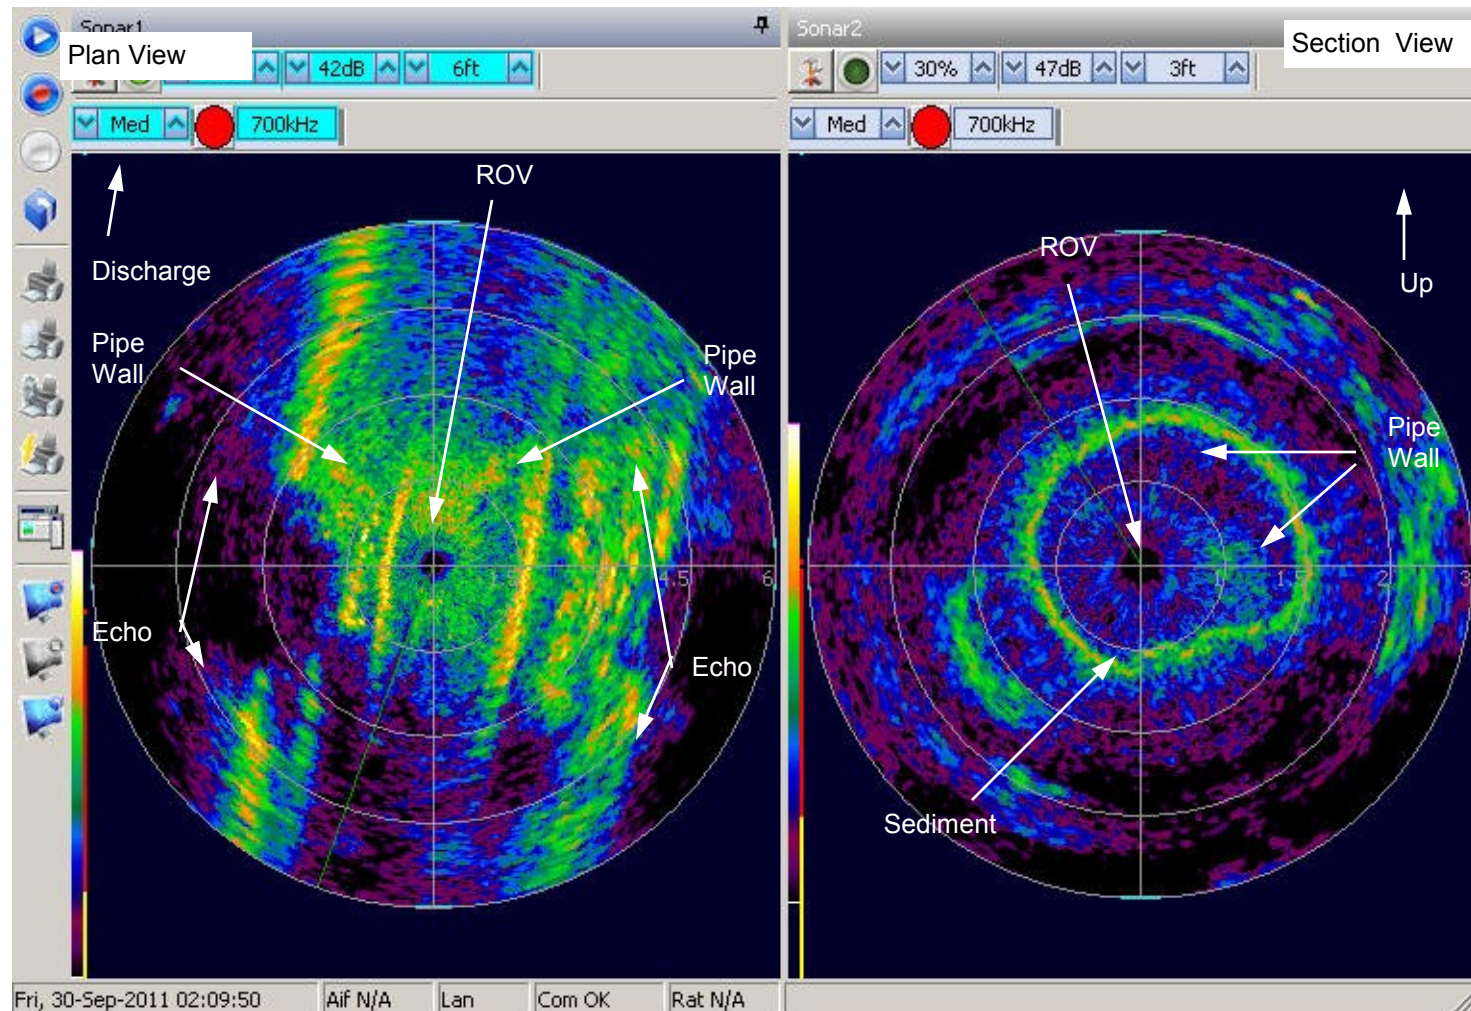
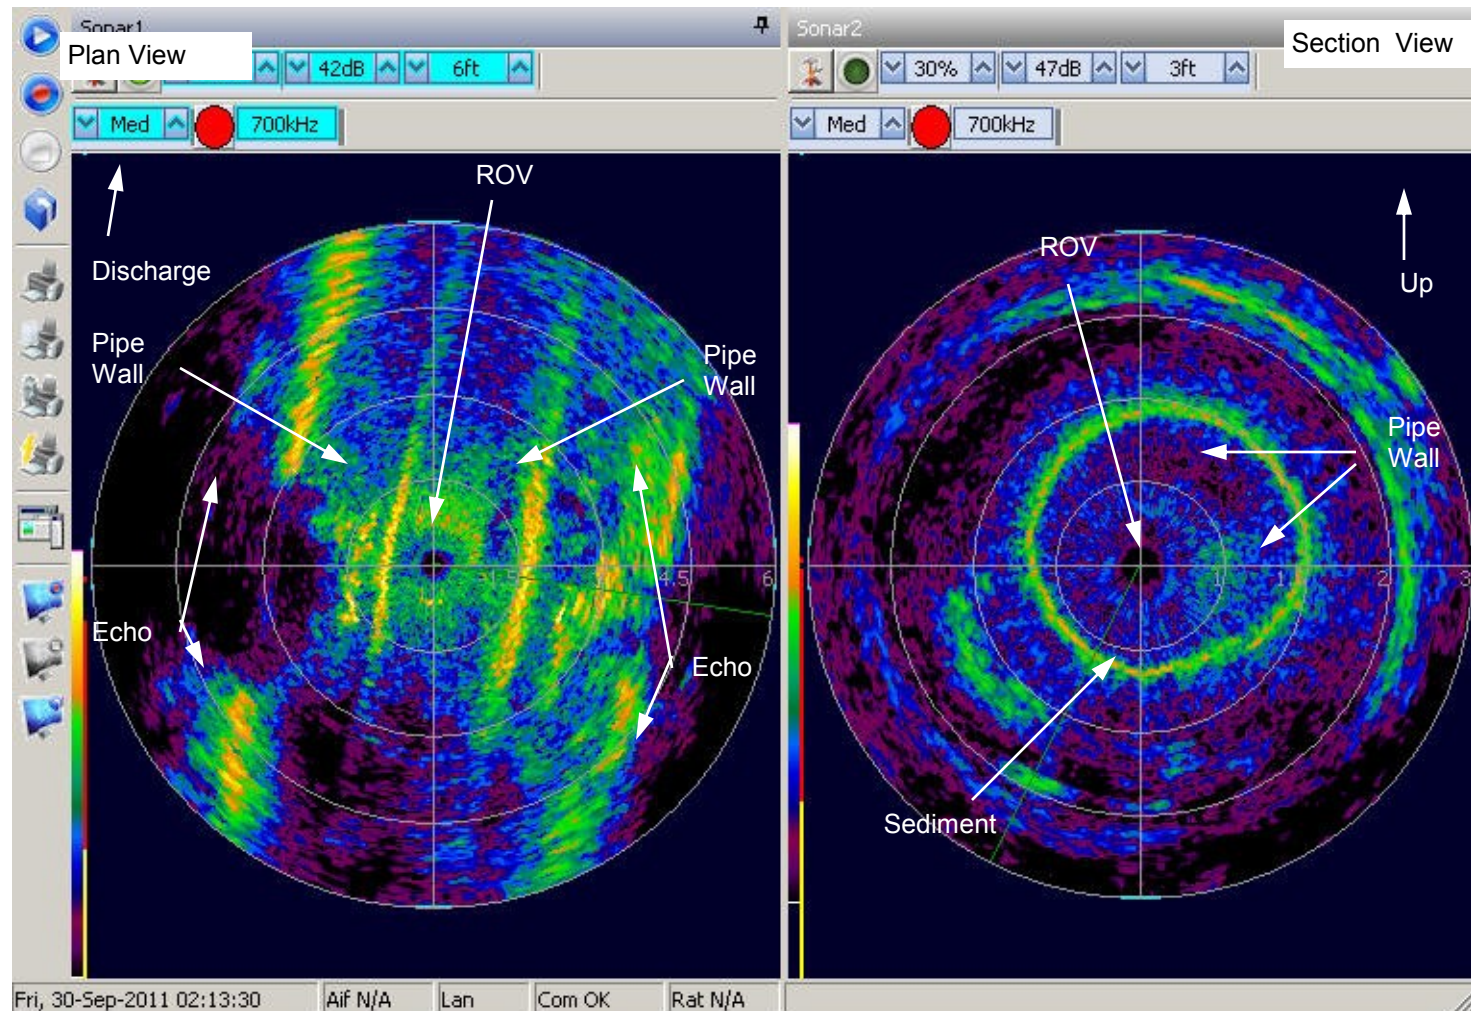
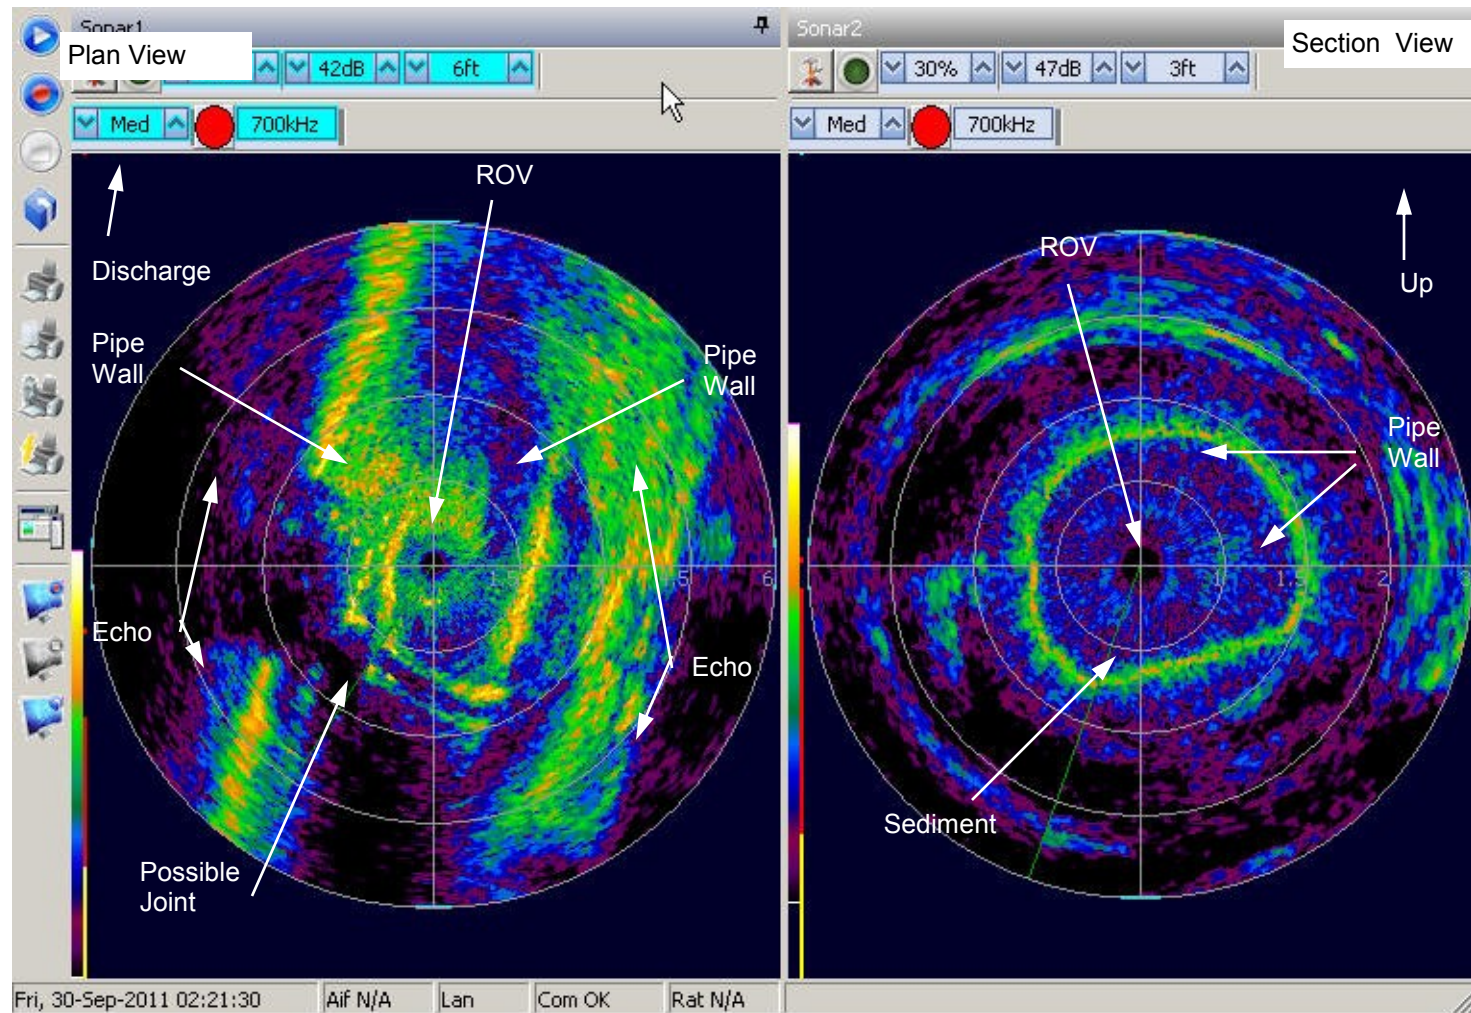
Notes: Approximately 3" of sediment.

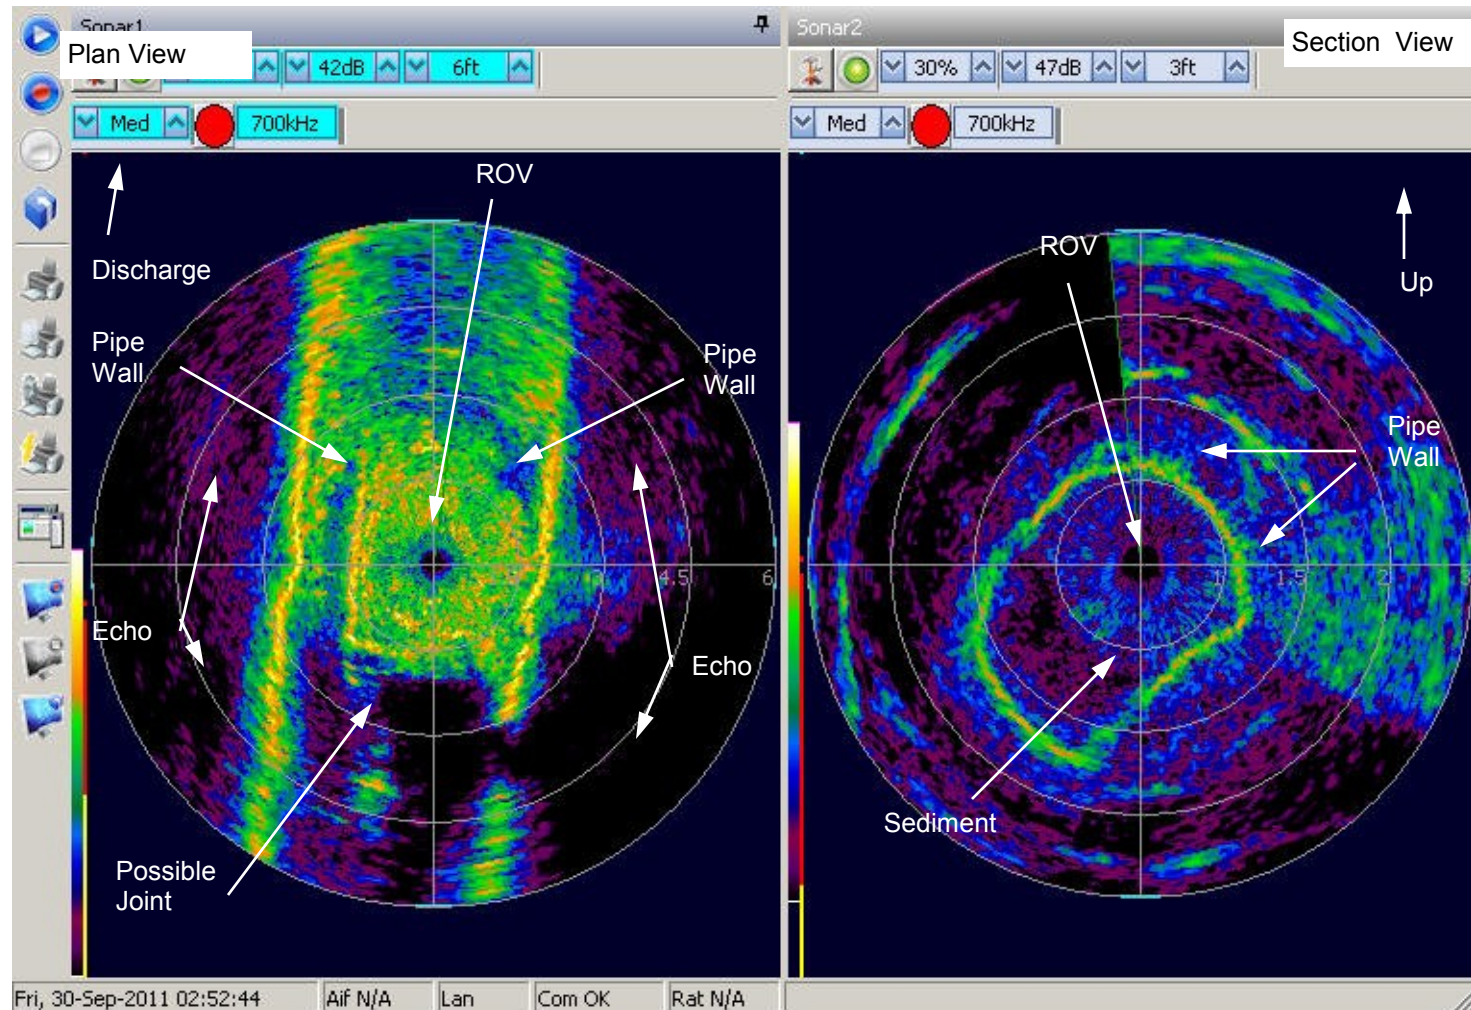
File Name: MorroSept042.jpg
Tether payout: 5500 feet

Notes: Approximately 4" of sediment.

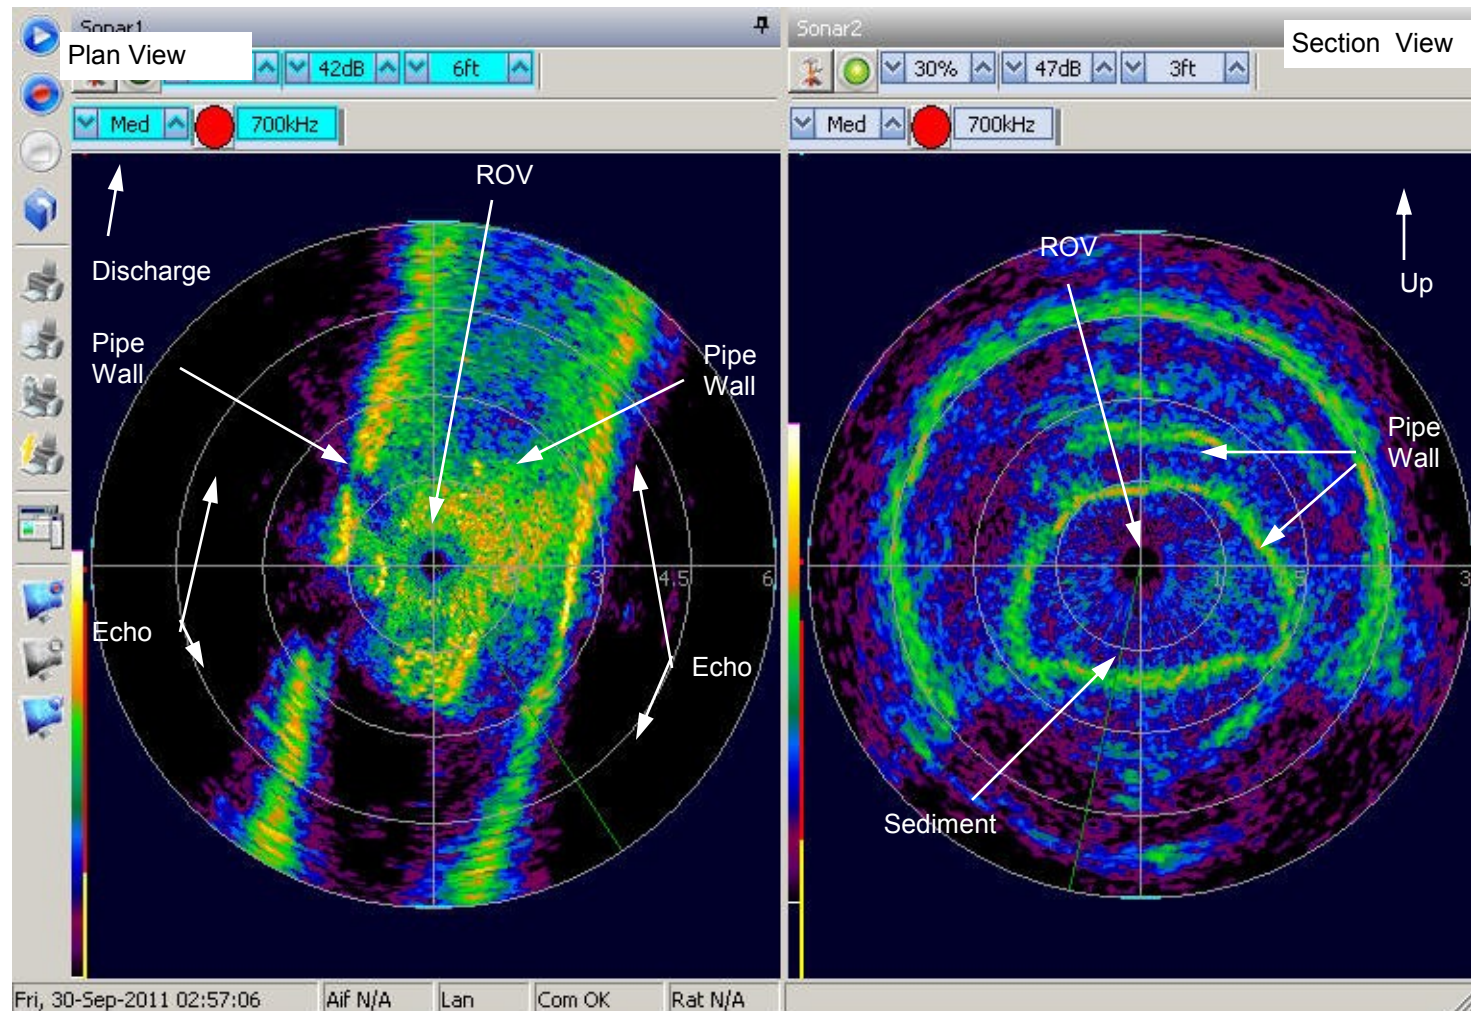
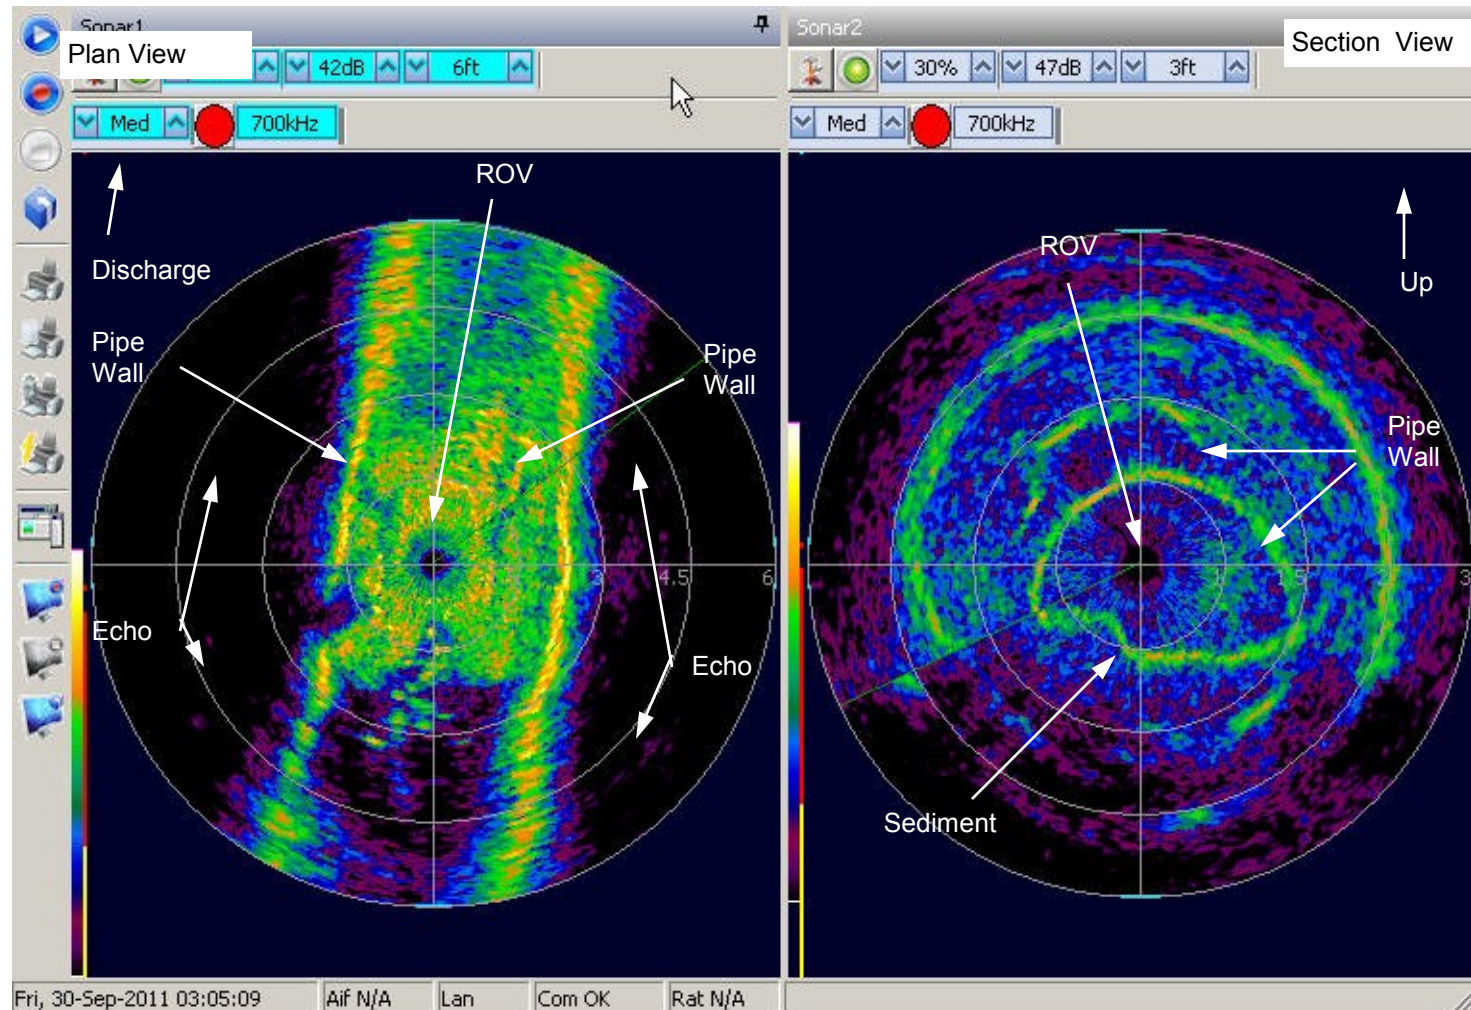
Notes: Approximately 6" of sediment.
