City of Morro Bay
Water Reclamation Facility Project

OUTFALL ASSESSMENT PLAN

DRAFT | March 2020

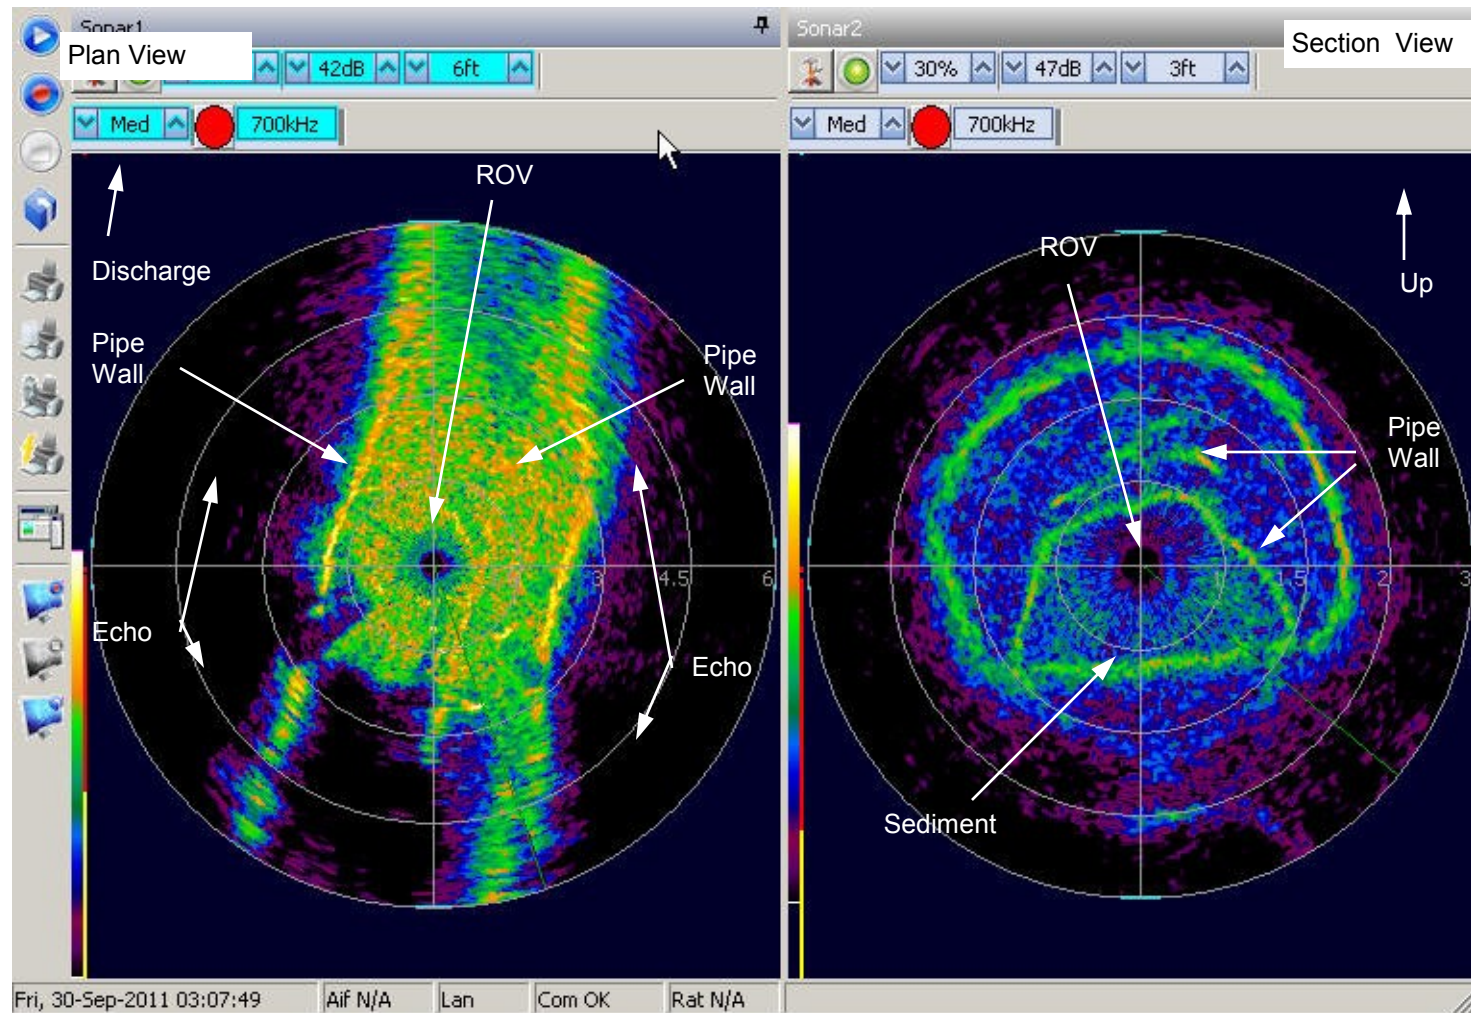
File Name: MorroSept045.jpg
Tether payout: 5900 feet

Notes: Approximately 6" of sediment.—too much for ROV to pass
