City of Morro Bay
Water Reclamation Facility Project

OUTFALL ASSESSMENT PLAN

DRAFT | March 2020

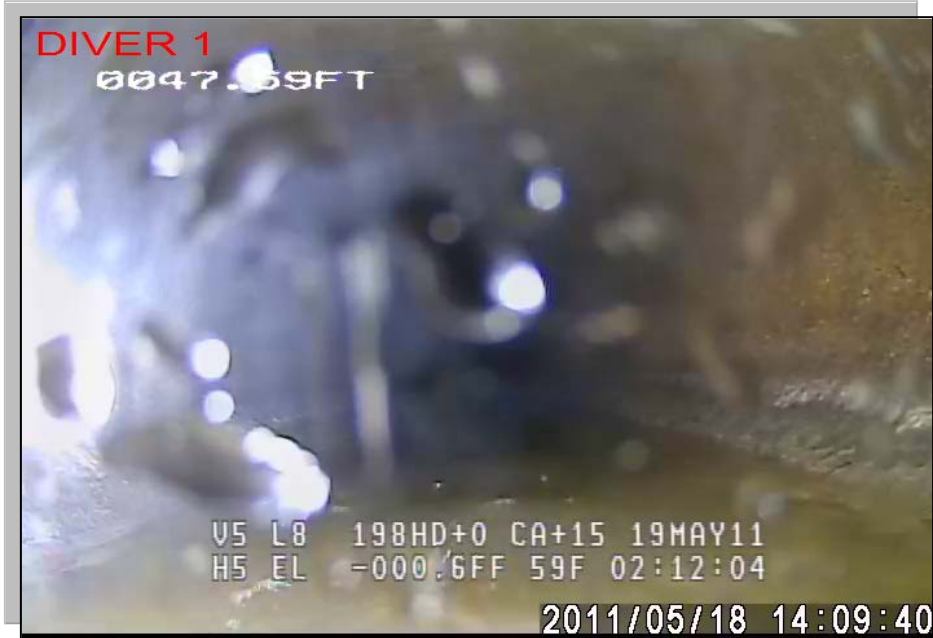
Figure 1 - View of dry portion of pipe

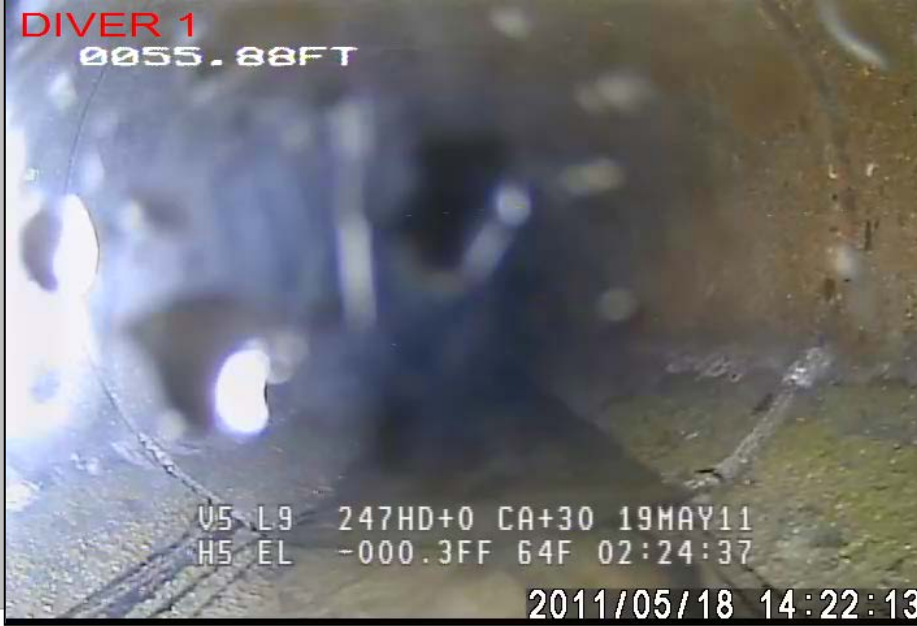
Figure 2 - Typical Joint

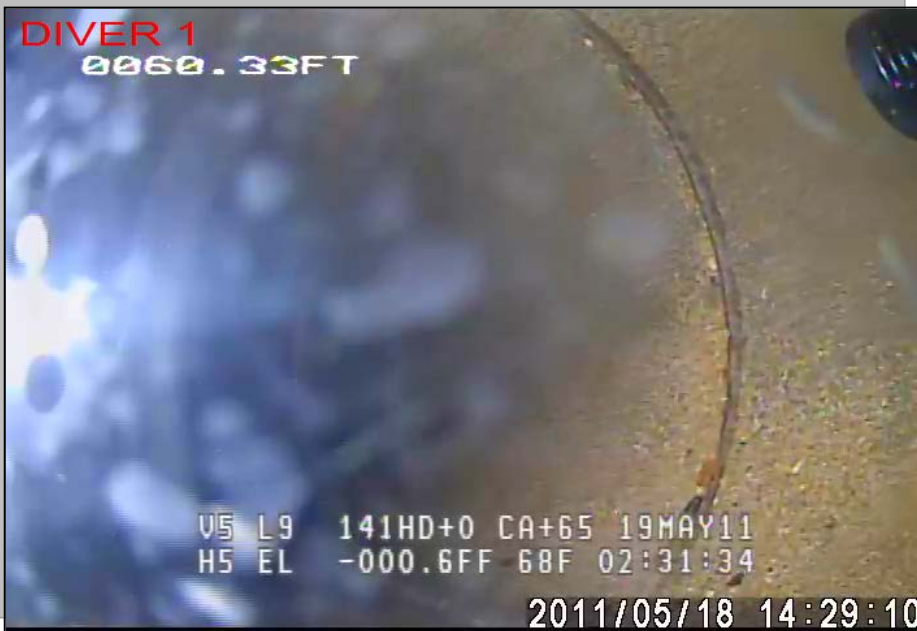
Figure 3 - Closer View of Typical Joint

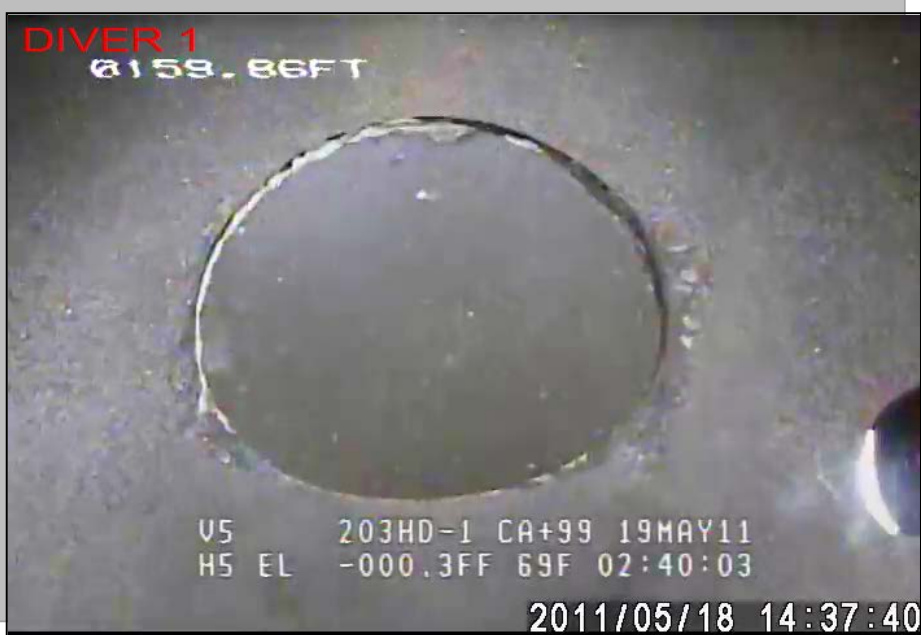
Figure 5 - Circular Plug in Crown of Pipe

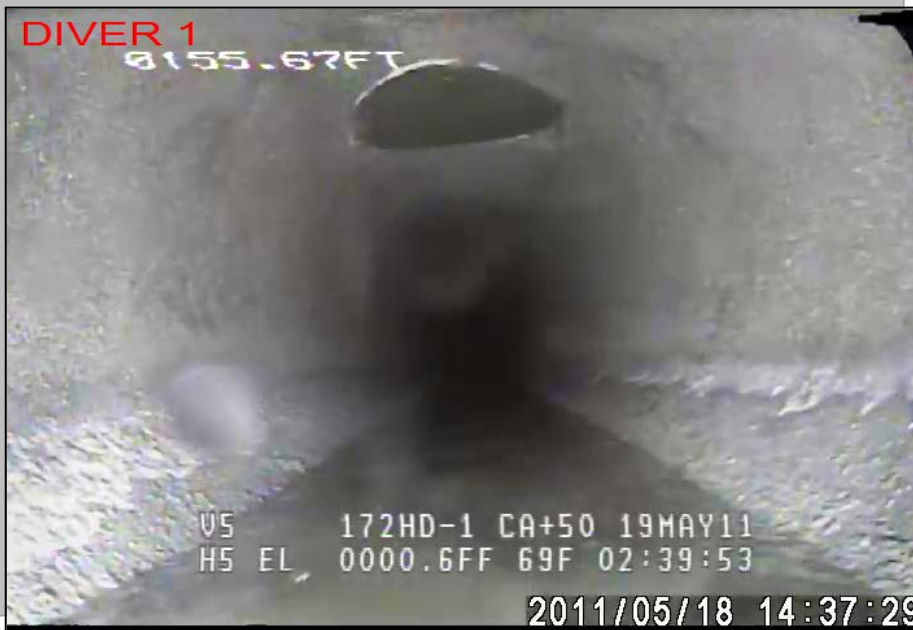
Figure 6 - Different View of Circular Plug in Crown at 155'

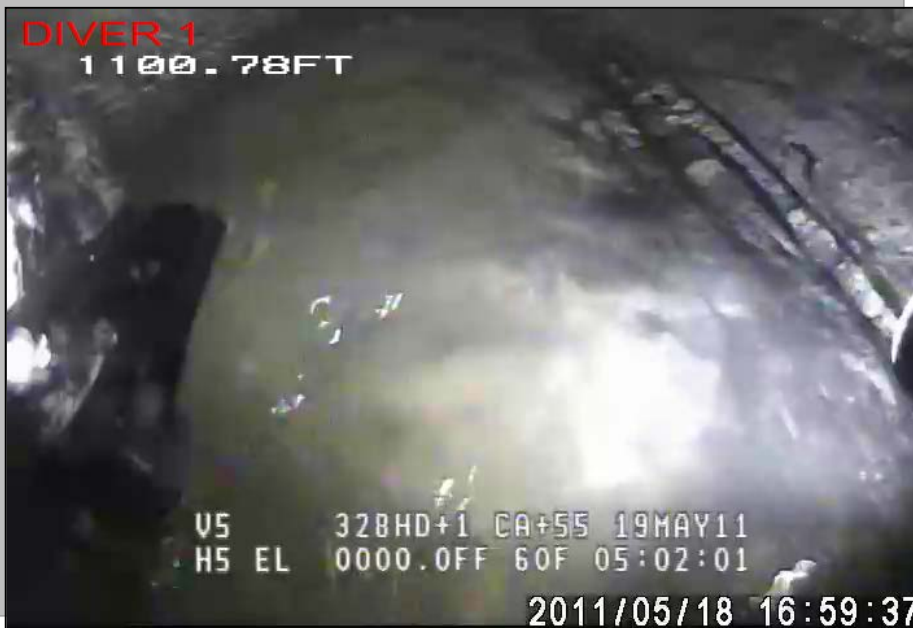
Figure 7 - Debris Caught on Left of Manipulator

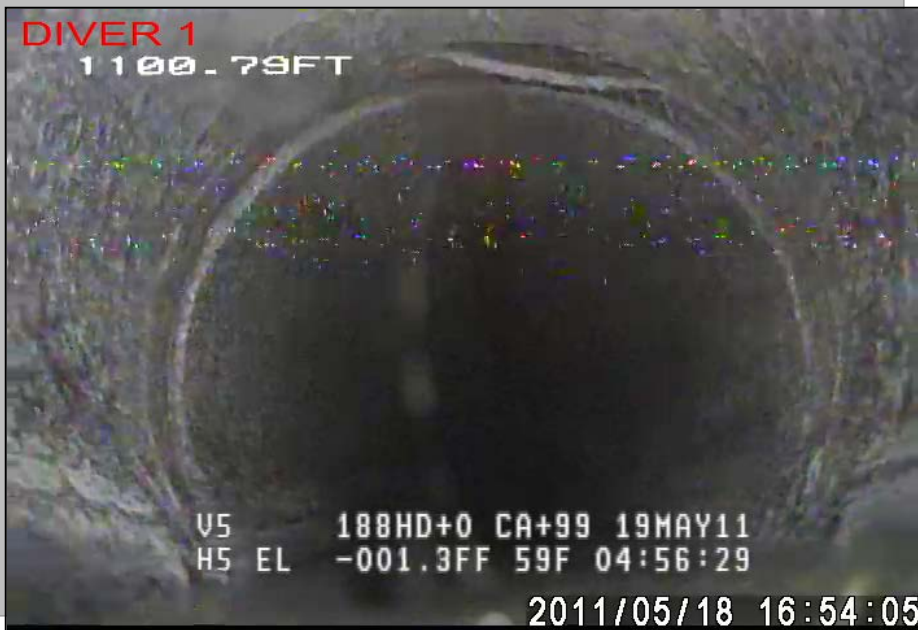
Figure 8 - Joint Seal Hanging from Crown

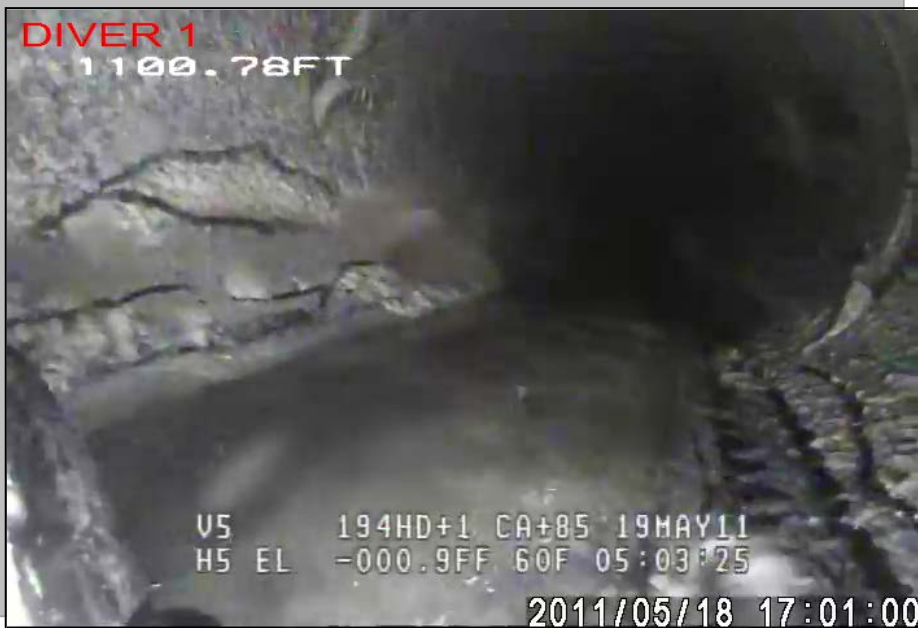
Figure 9 - Joint Seal Partially Detached from Pipe and Downstream Portion of the Bend

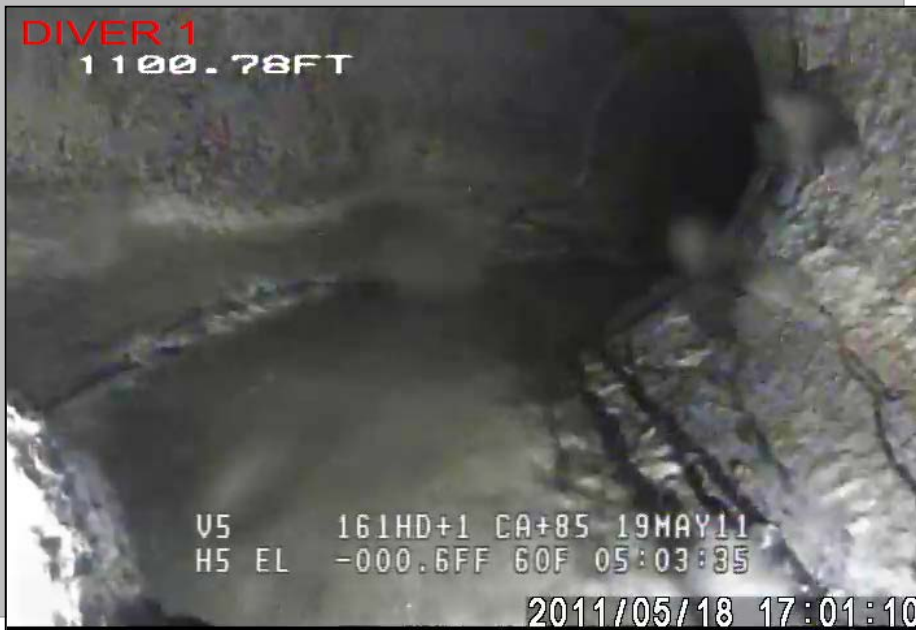
Figure 10 - Bend in Pipe

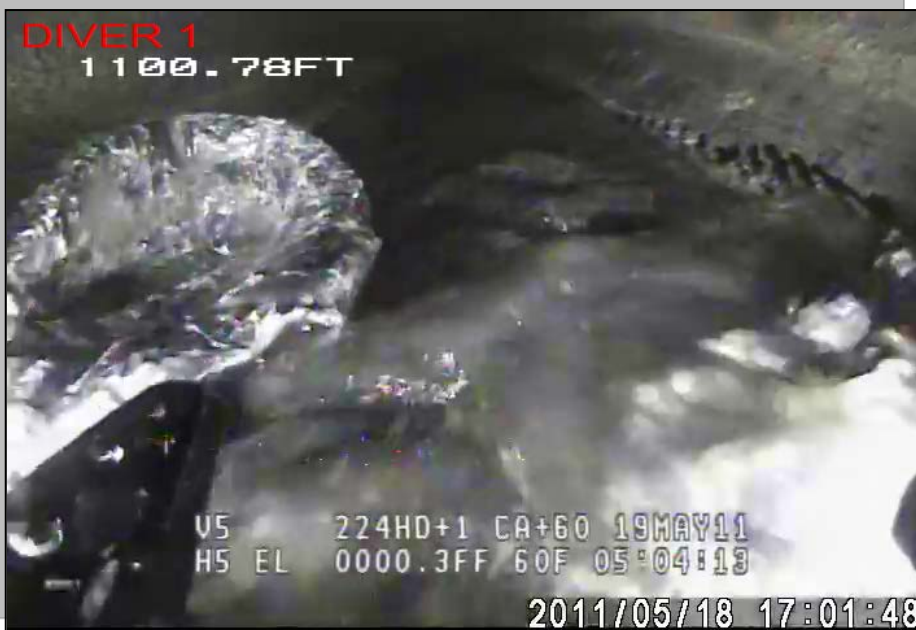
Figure 11 - Debris Under ROV

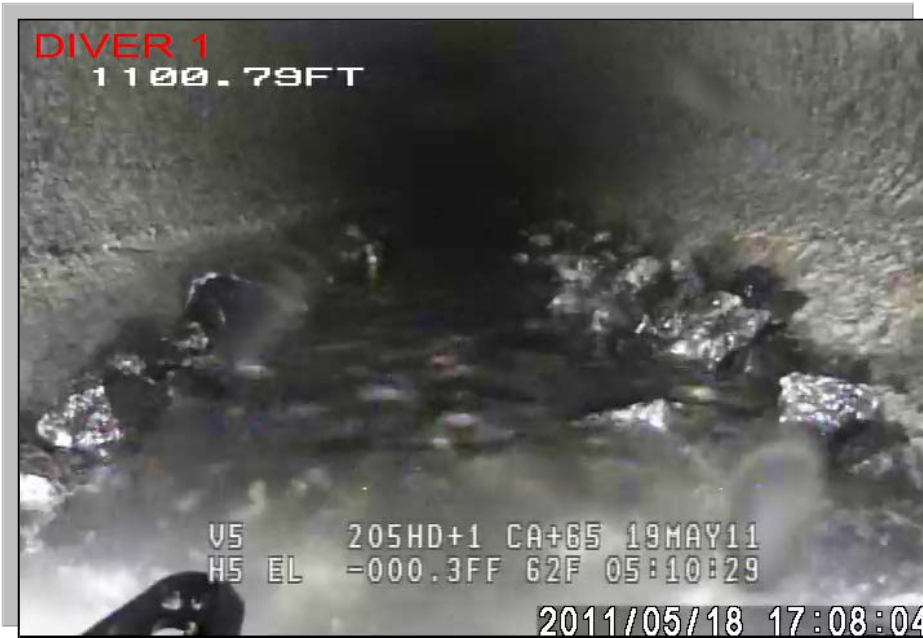
- Small debris piles on the invert of the outfall ranged from 1 to 2-inches deep. Debris material consisted of loose sediment, gravel, rubber joint seal sections or pieces of pipe corrosion.
- No significant cracks or out of round conditions were measured.
- Sections of joint seals were hanging from pipe joints.
- 7 of the diffusers were not flowing.

Figure 12 - Typical Debris on Invert

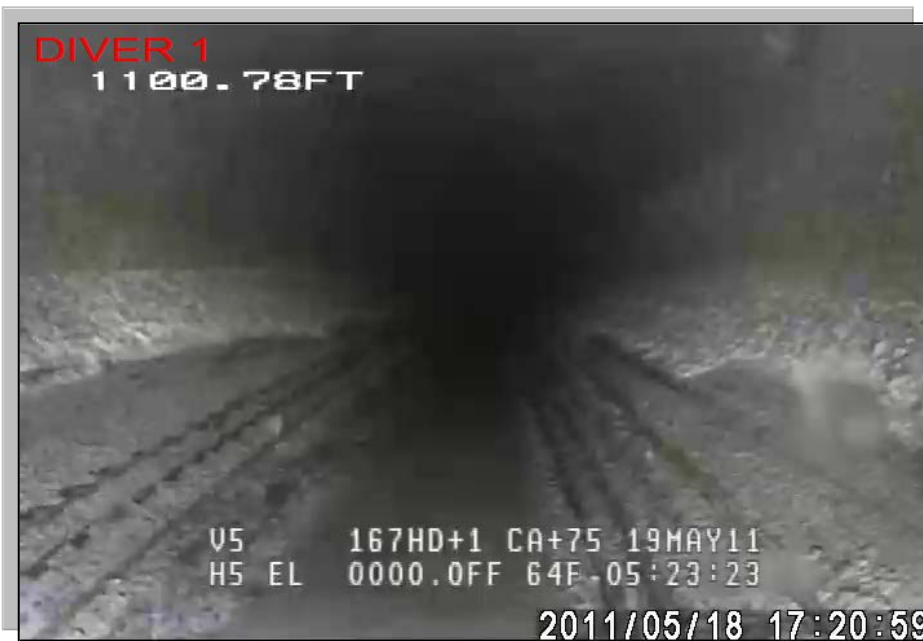
Figure 13 - View of Pipe without Effluent

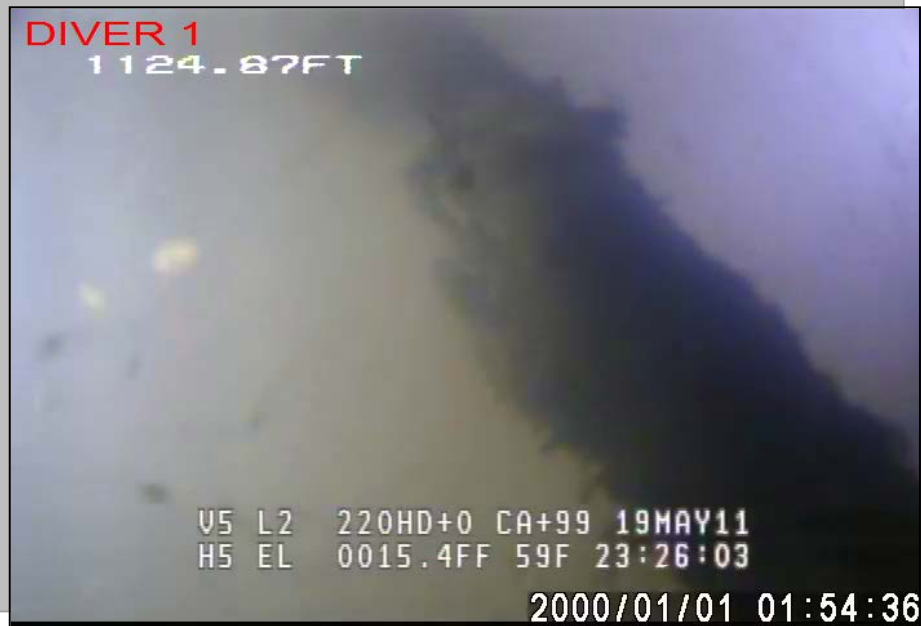
Figure 14 – Seal Debris Partially Blocking Pipe

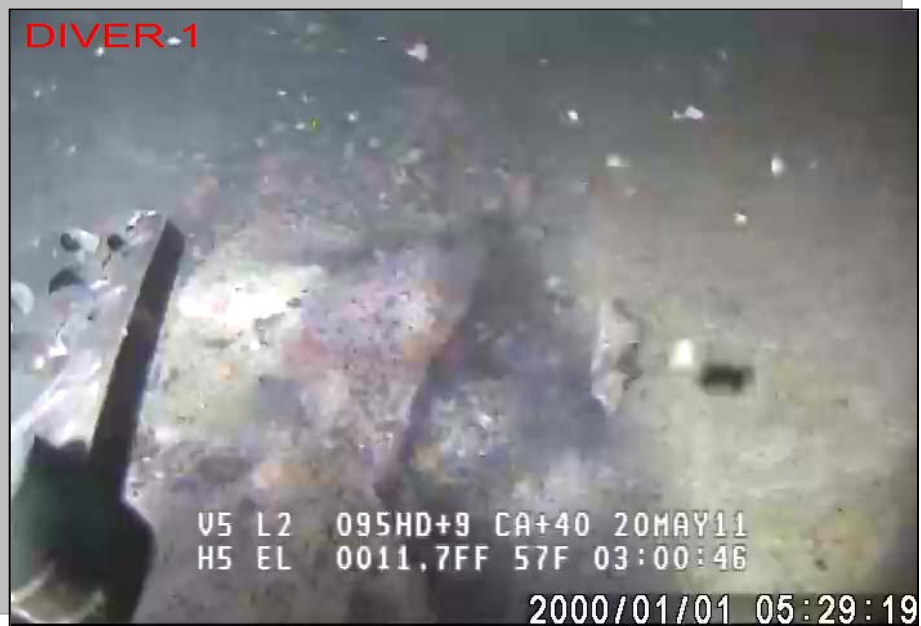
Figure 15 - Debris on Invert between 1300' and 1200'

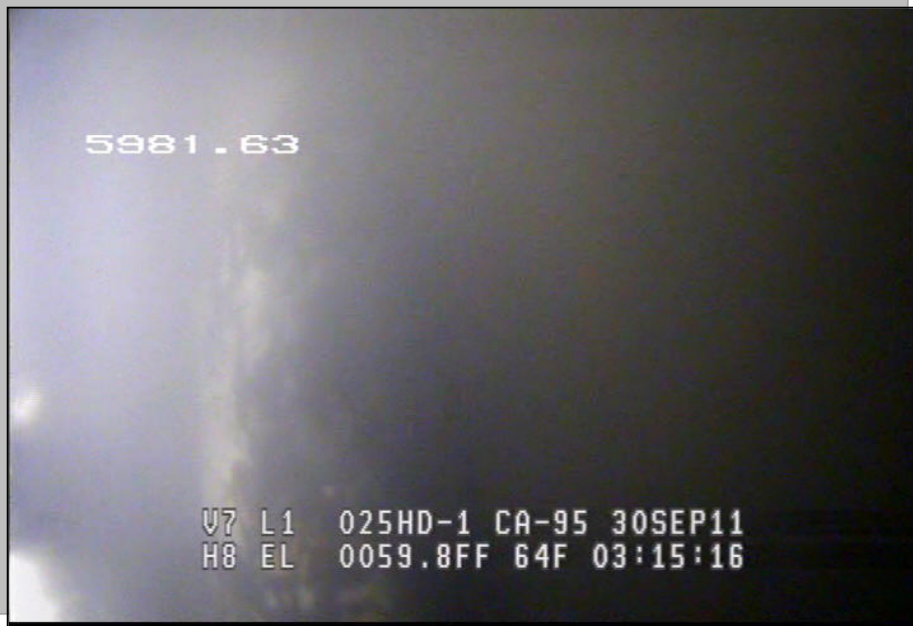
Figure 20 - Debris Caught in ROV Frame at End of Pipe at 4982'

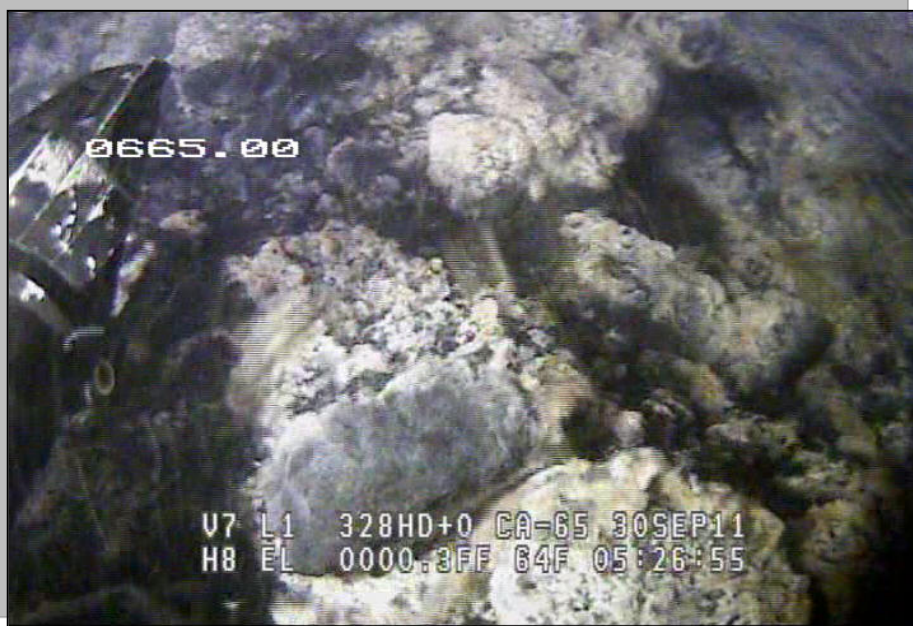
Figure 21 - Invert Debris at 665'

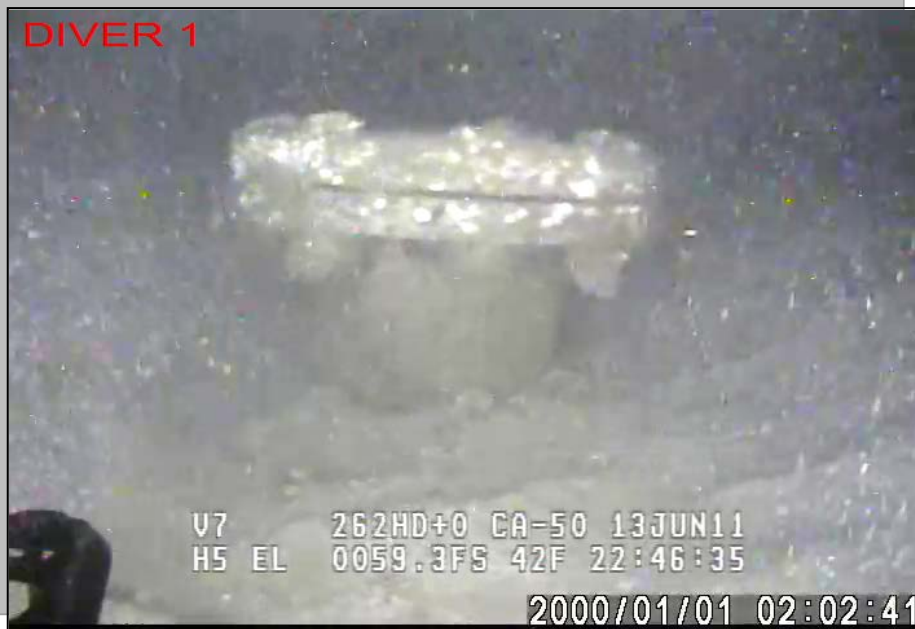
Figure 22 - Stand Pipe at End of Outfall

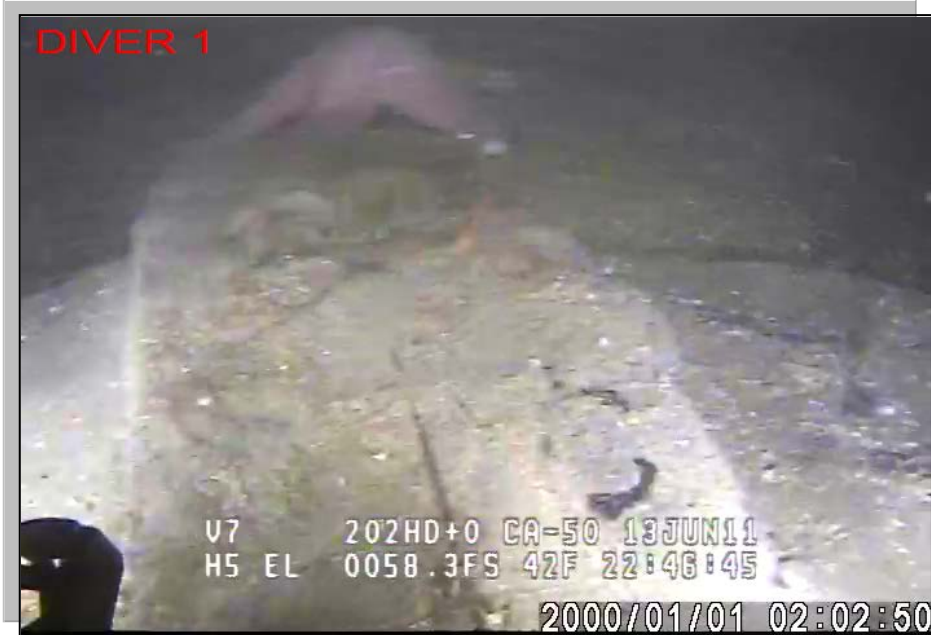
Figure 23 - Blind Flange on End of Outfall

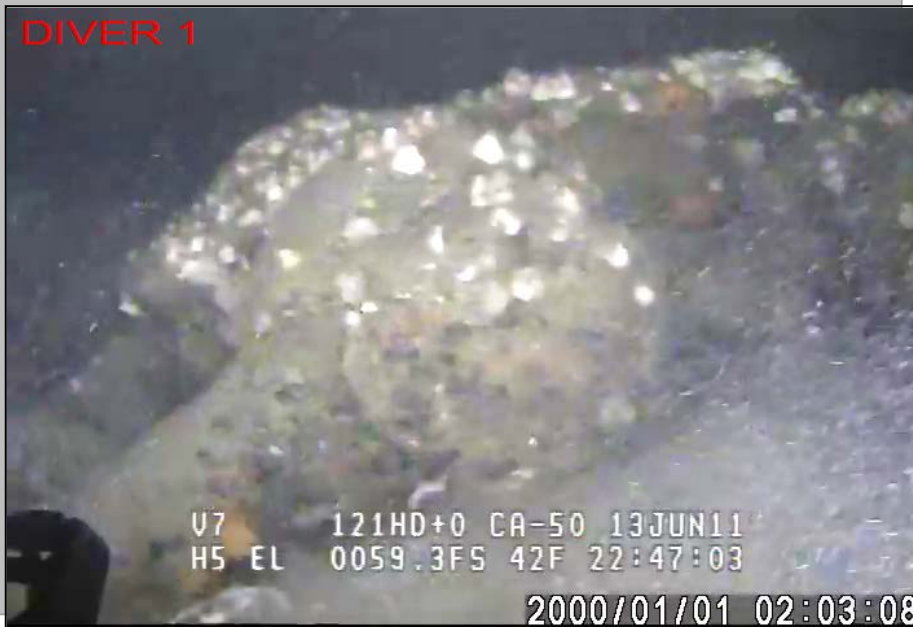
Figure 24 - Anchor Chain at End of Outfall

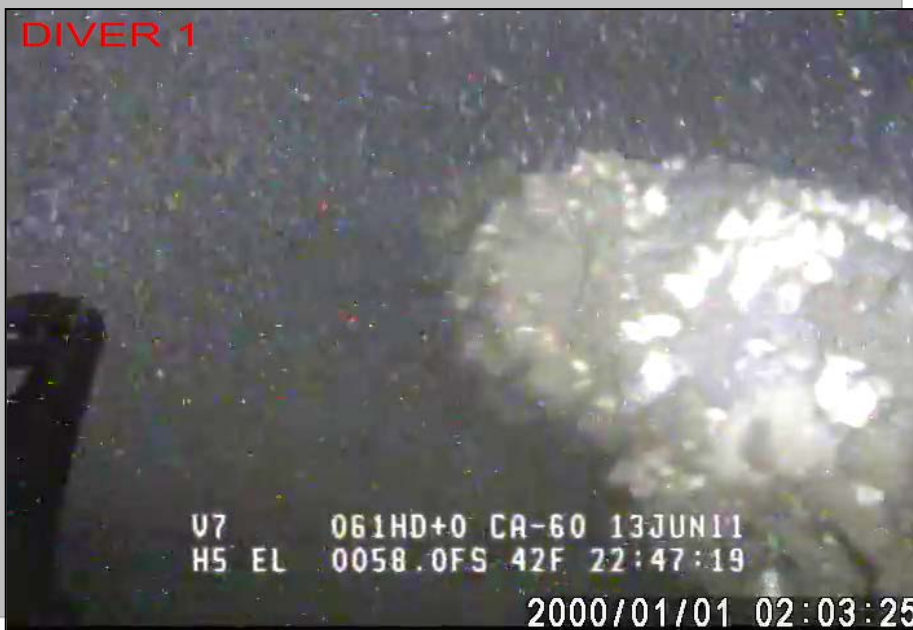
Figure 25 - Typical Diffuser and Flow

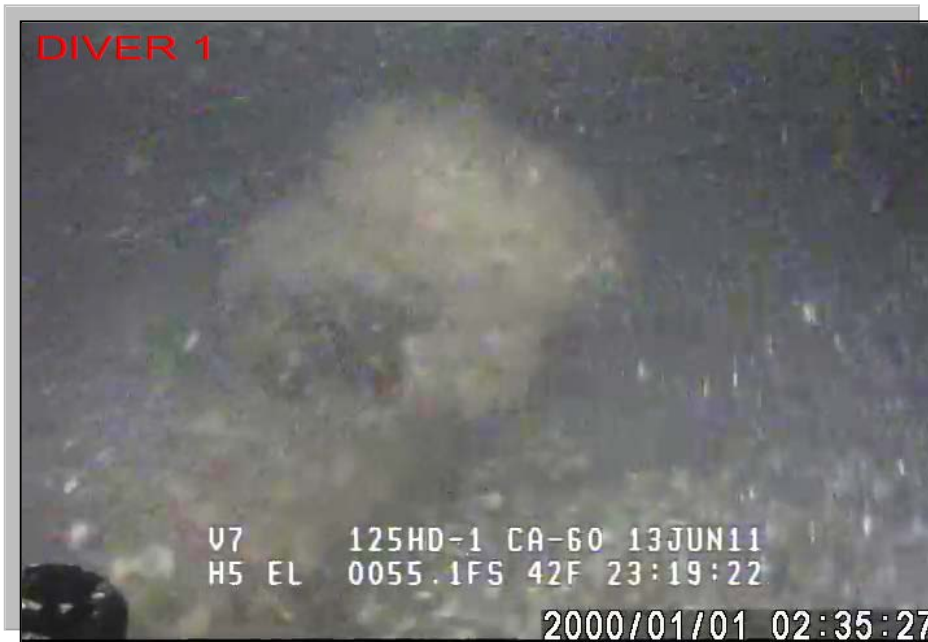
Figure 27 - Capped Diffuser (one of last 6)

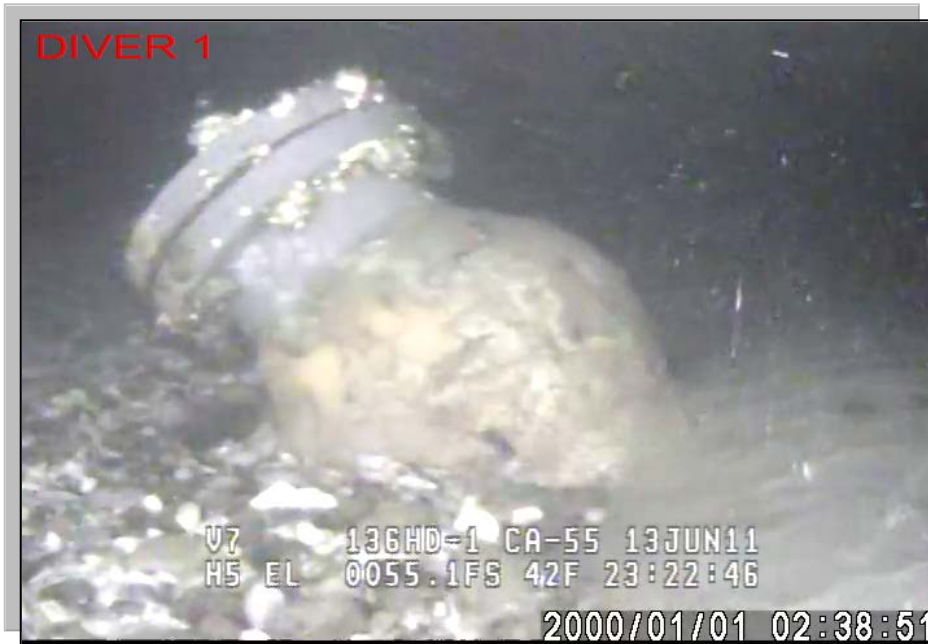
Figure 28 - Capped Diffuser Closest to the Shore
